SPECIFIC DEFECTS REPORT

**Independent Survey
for roofing work
new build
at
XXXX
Wyboston
Nr Bedford
Bedfordshire
MK44 X**

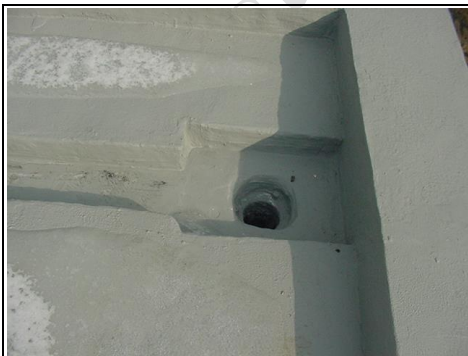
Gully from roof level

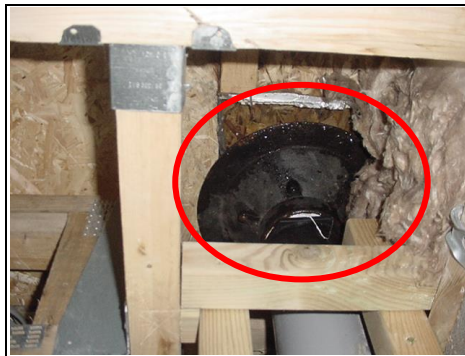
We have been advised by the developer and project manager that there has been rainwater coming into the roof since the roofs' completion particularly around the down outlet points and the internal gully.

Outlet and gully within roof area

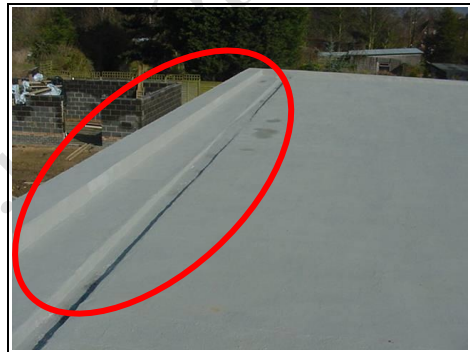
Investigations would indicate that the main problem is with the downpipe outlet. We also obtained higher than expected timber damp meter readings to the decking beneath the running gulley on the roof. Without core samples we do not believe that we can discount problems with the roof finish itself as from what we understand this was laid in less than ideal conditions.

Running gulley

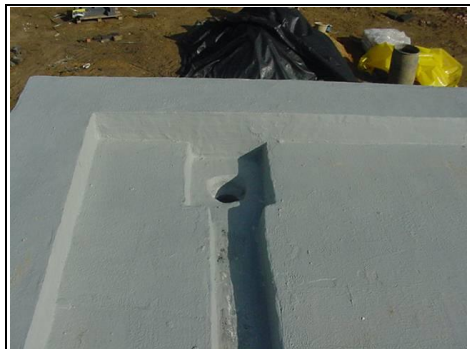
Downpipe outlet

As such it would appear that the positioning of the outlet and construction around the outlet is the main issue assuming that XXX is found by core samples to be a waterproof material which we would expect given that it has been in use for many years; nevertheless we require core sample testing to verify this.

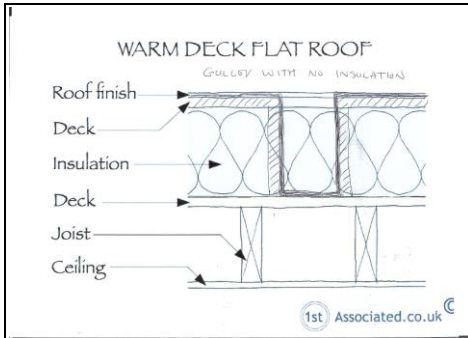
Without opening up the structure it is not possible to understand exactly how the gulley runs have been constructed. It may be that the existing gulley may cause cold bridging (as we believe the cast iron to the outlet is doing) as you can see from our sketches.

1. Gully with no insulation and possibility of cold bridging

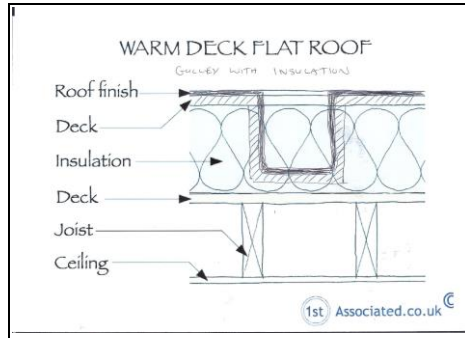
2. Gully with a small amount of insulation possible cold bridging

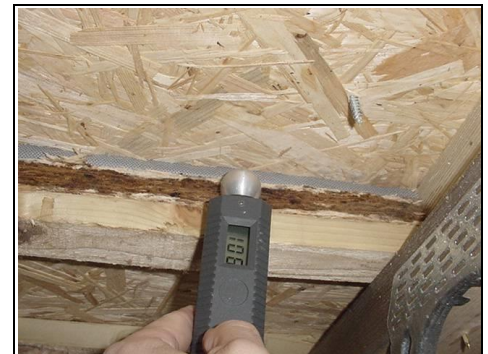
Damp meter readings underside of the gully

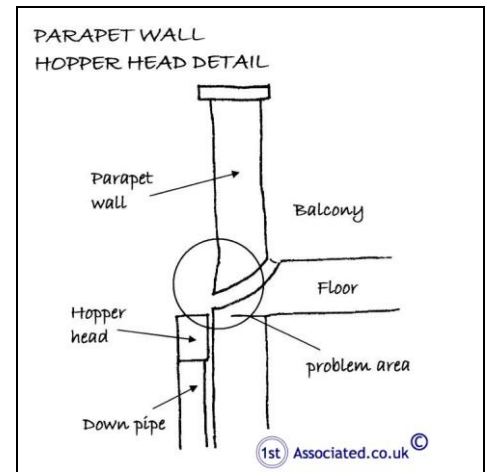
Hopperhead

11.2) To provide an external downpipe in the form of a hopperhead.

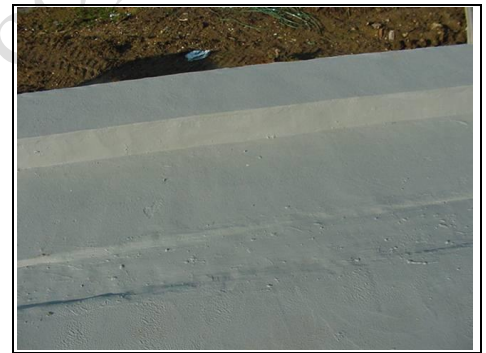
As we understand it there is a proprietary cement based roofing system known as XXXXX being applied within a three layer expanded metal lath system to the roof (no expansion joints) and this has then had a acrylic paint finish applied to help provide a smooth finish.

Stippling/puckering to roof surface

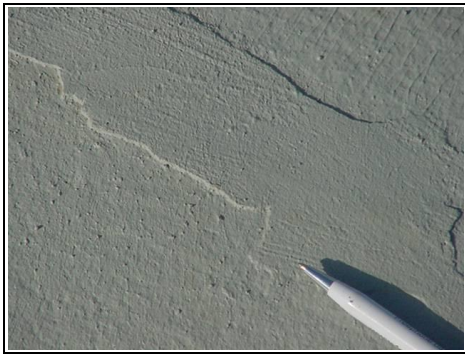
Underlining the acrylic finish we believe the XXXXX finish to be uneven although it is difficult to be one hundred percent certain. Inconsistencies would appear to be thicker than would normally be found within a paint.

Close up showing different layers

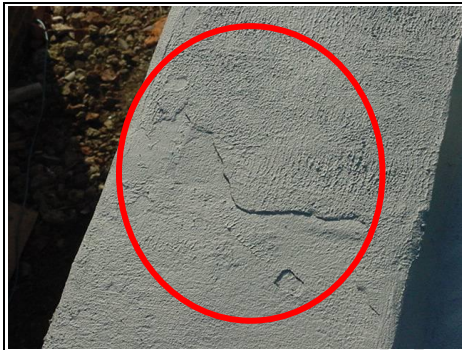
Inconsistency in finish

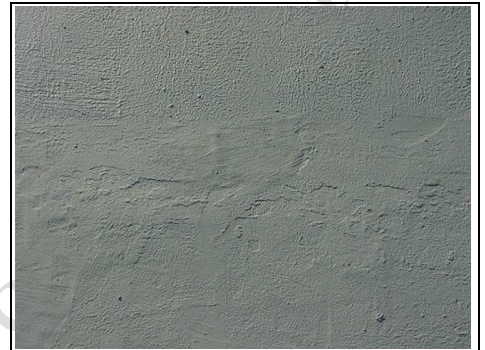
Close up of surface

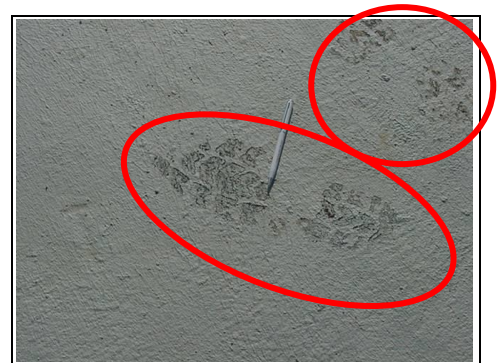
For example: Footprints particularly to the left side.

Footprints

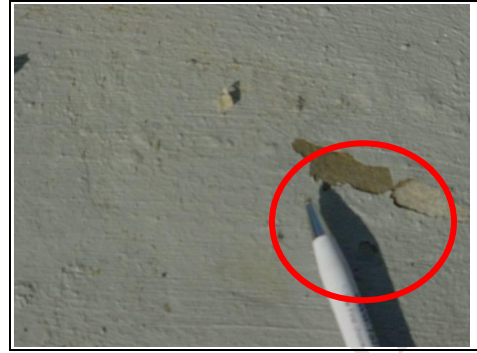
To the front left side there is surface deterioration with the surface coming away.

Close up of area of surface coming away

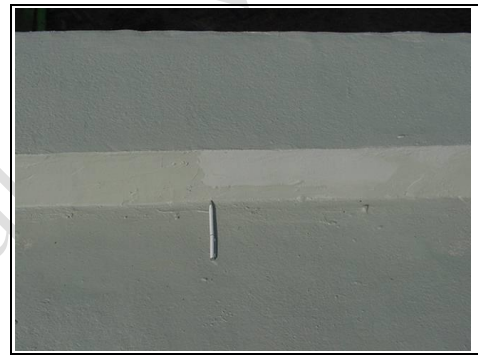
We noted in some areas there are lighter and darker colours.

Different colours different layers

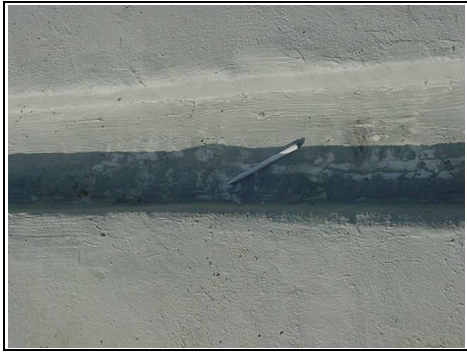
Marks within box gutter

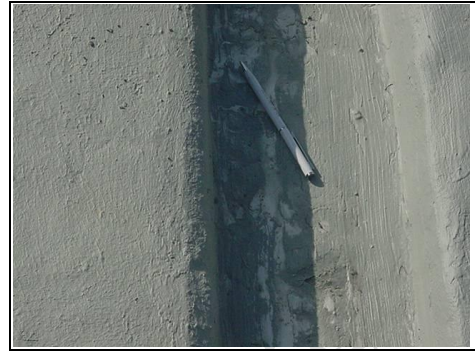
Close up of box gutter

The underside of the box gully was checked with a damp resistance meter which indicated dampness present to the timber below. Please see our further comments.

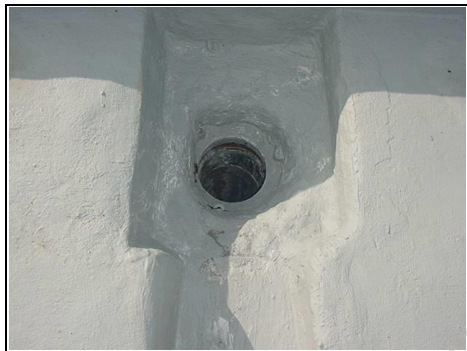
Acrylic paint has been painted over fixing holes for the leaf guard

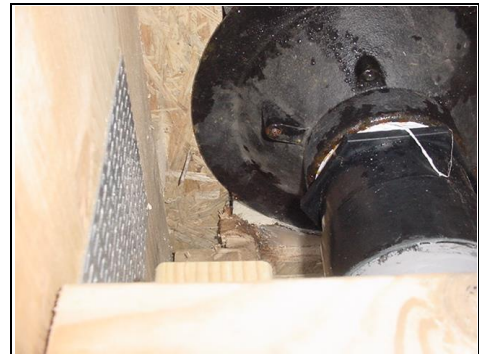
Rusting to bottom and screws

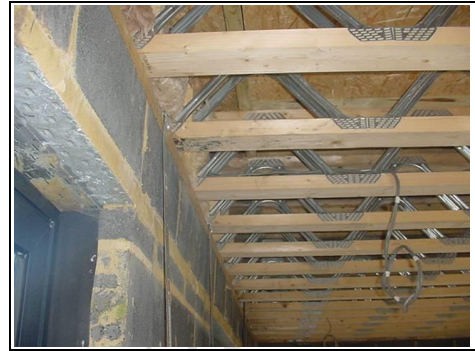
We could see some areas of timber to the joists are darker. We were advised by the builder that there were inconsistencies in the original joists and they do not believe they are part of the roof problem but cannot be certain.

Joists forming support to roof decking

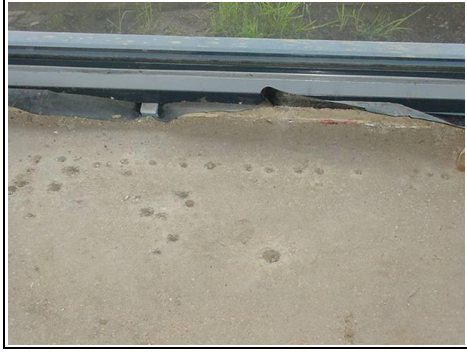
Pattern staining

Advised by builder rain came through roof when it was being constructed originally and left pattern staining

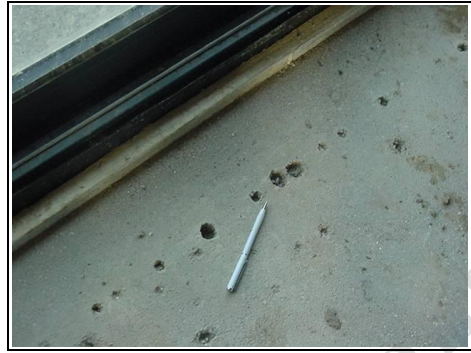
Pattern staining
Rear right

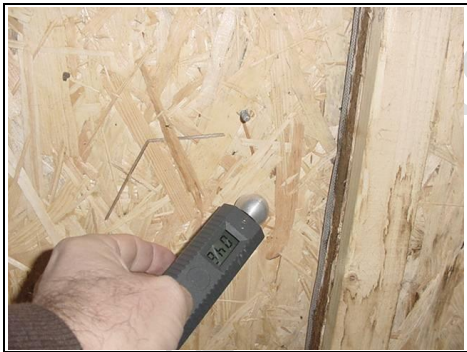
Reading 46
Base of decking

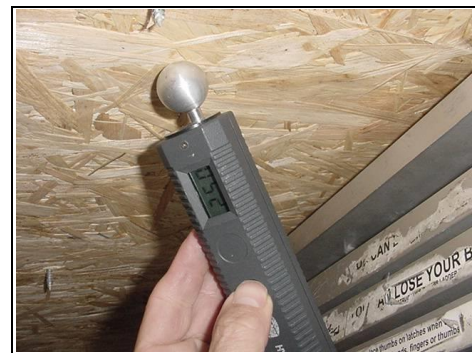
Reading 52
Away from box guttering

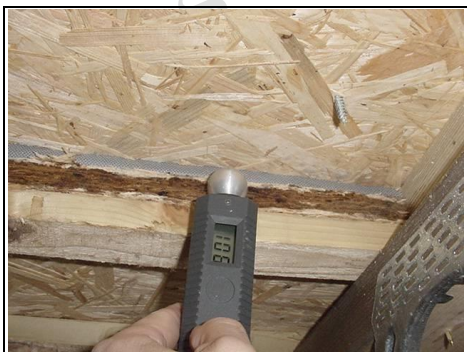
Reading 106
Against box guttering

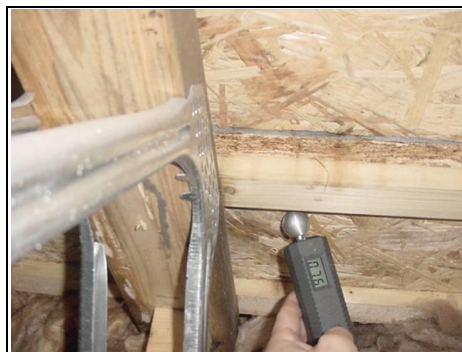
Reading 76
Base of box gutter

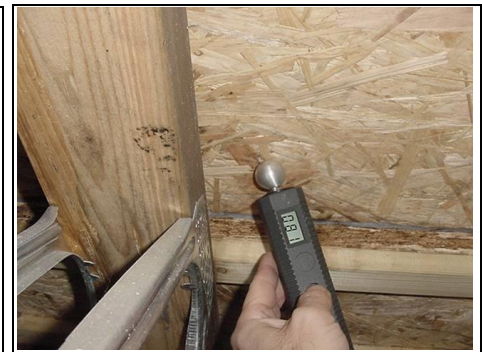
Reading 81
Area close to box gutter
