SPECIFIC DEFECTS REPORT

Relating to main roof problems,
xxxxxxxxxxx,
Islington, N7 xxx

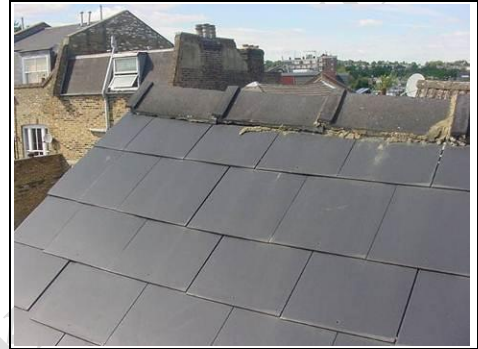
The main roof is pitched and clad with a manmade slate with a parapet wall to the front and small parapet walls to either side within the valley gutter.

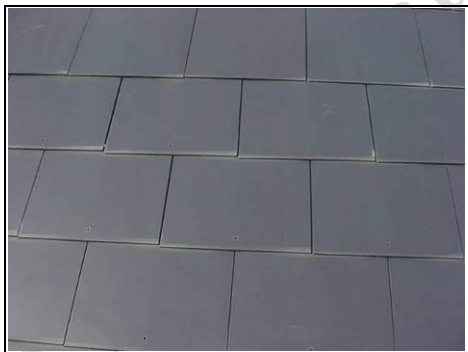
The manmade slates are not fixed properly to the rear of the property and they look to have been masticed into place. The life of this area is limited as they should be mechanically fixed with metal pins as they are to the front of the roof.

The slates on the main roof look to have been masticed in place

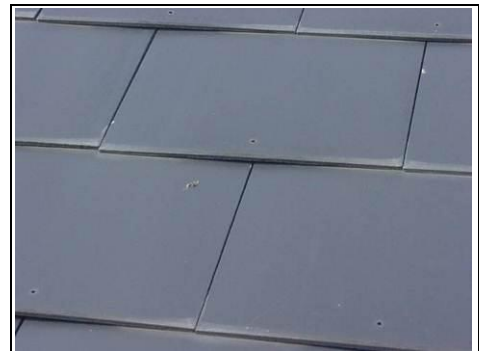
Close up of slates with no metal pins holding them on

We do not believe the main problem is due to the slates being wrongly put on the roof but we do believe in the long term that they will become unsecured. This will allow rainwater in.

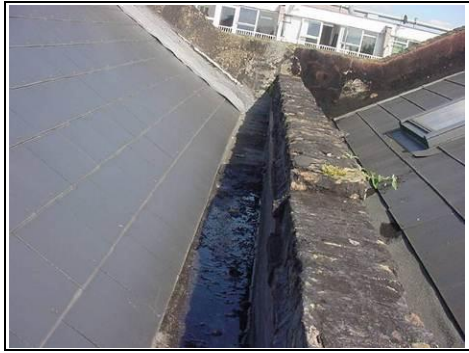
This has a mineral felt finish which is not ideal. There is ponding indicating that the water does not run towards the outlet.

Valley gutter to the left hand side (all directions given as you face the property). Ponding is visible on it.

ACTION REQUIRED: We would recommend that the detailing, where the roof meets the parapet walls to the front and side, is carried out in lead.

We would recommend renewing all of the flashings, ensuring that they are lead and checking that they work. We would also recommend ideally lining the valley gutter with lead. However if you do wish to sell, in the short term, another coat of mineral felt (high performance felt with elastomeric) would help the situation as long as it is suitably lapped underneath the slates. Note some contractors will give an insurance backed guarantee on this type of work.

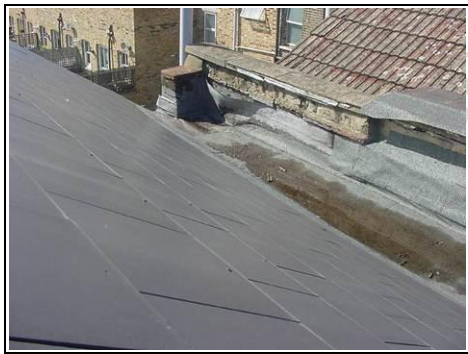
This has a mineral felt finish and we can see that the flashing has come away completely to the rear section.

Valley gutter to the right hand side (all directions given as you face the property). This was difficult to view.

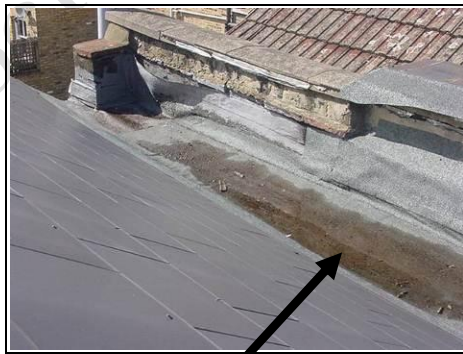
Ponding visible

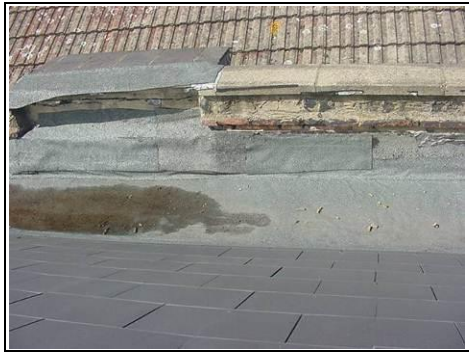
Lack of any decent flashing at all to the middle and front of the right hand valley gutter

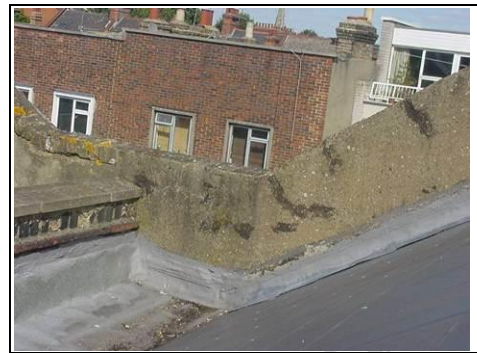
Flashing not fitted correctly to the front right hand side

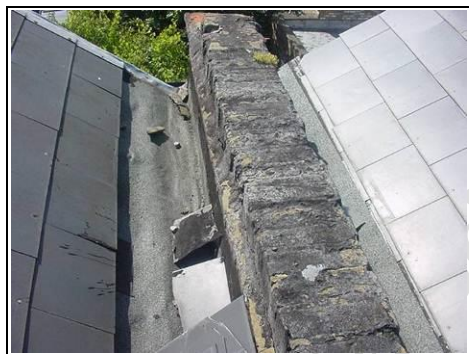
This could affect you as it is in poor condition with the felt becoming un-bonded

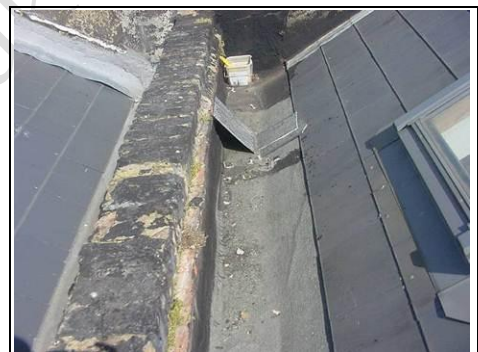
Bitumen paint used

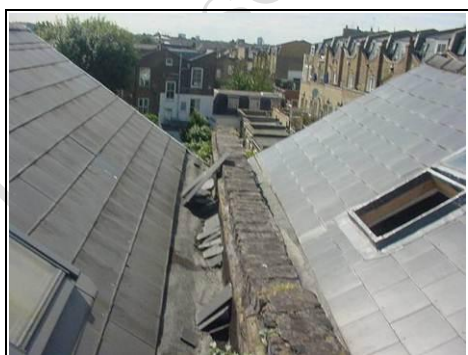
Many slates have been damaged

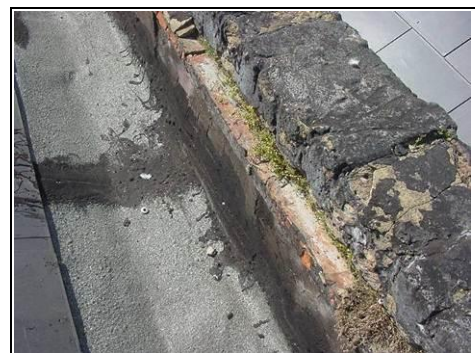
Bitumen repair. Also note the parapet wall is letting in water which is why the plants are growing from it

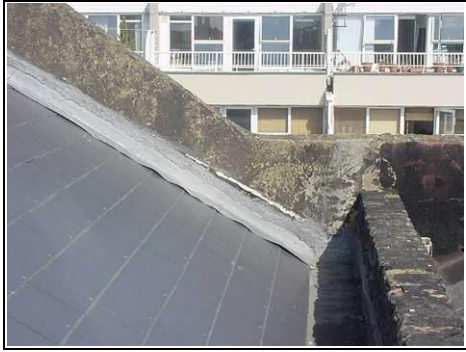
The flashings appear defective as they are letting in water

Flashing to the front that's not bedded properly

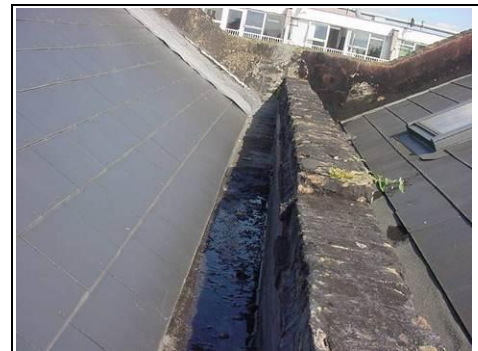
These need to be sealed as the soft red brick that forms the walls draws in water similar to that of a sponge or blotting paper.

The parapet wall that is allowing water in. This explains the plant growing out of it. This needs to be made watertight

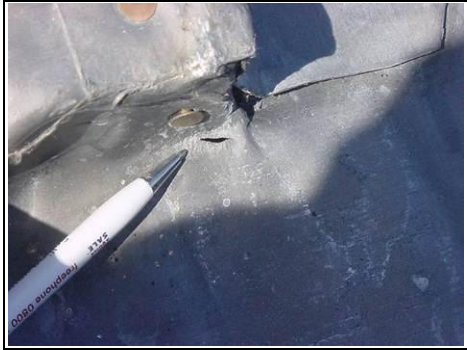
The access hatch is formed in lead and is purpose made as opposed to manufactured. We noted that there was no stop to hold and guide the roof light in place. It is literally held on by the lead.

Split lead to the access area

ACTION REQUIRED: We would recommend replacement of the roof light with a purpose made double glazed unit.

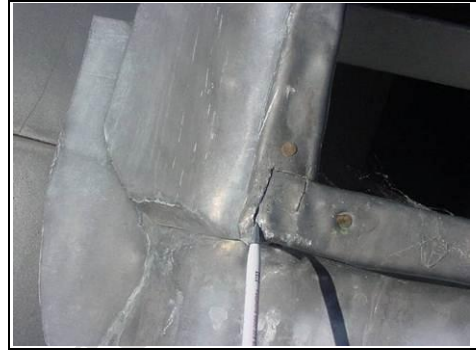
Damage to the lead

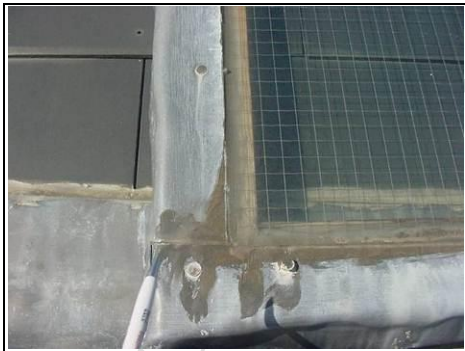
Mastic sealing to access area

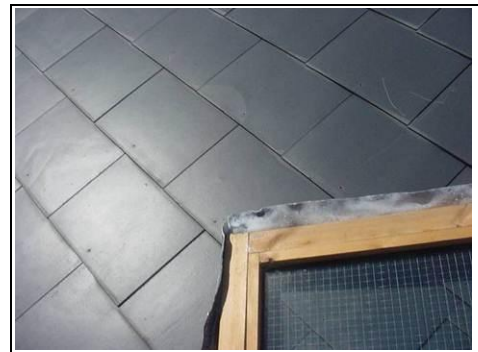
There is a lack of a stop on it.
This means the weight rests on the lead

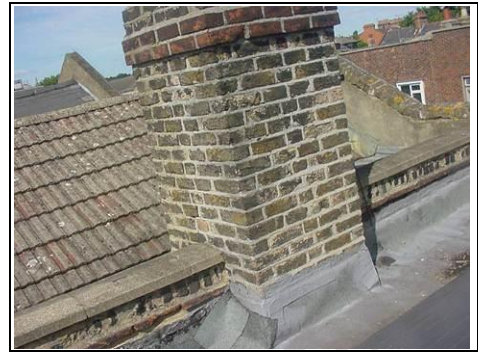
You need to check the flashings to the base of the chimney as the right hand chimney looks to have felt flashing repairs.

The chimney has felt flashing around it

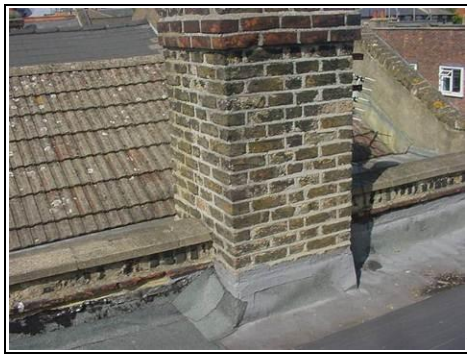
Felt on top of felt around the chimney

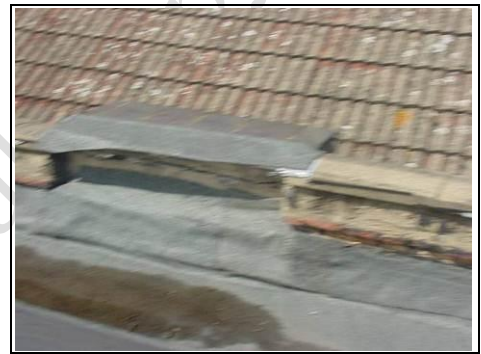
Chimney has been removed with a felt capping in place rather than a paving slab or concrete.

As discussed we recommend that if you do want to sell the flat then this is something that you negotiate a discount on as to carry out the work is very awkward as it's high level and may even require scaffolding.

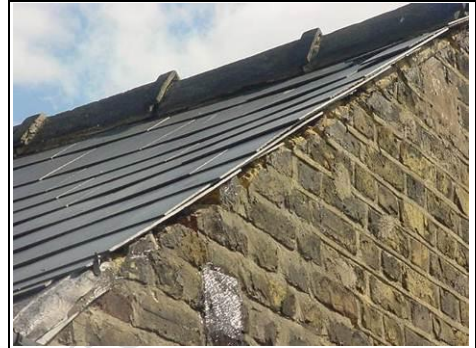
Close up of flashing put on incorrectly

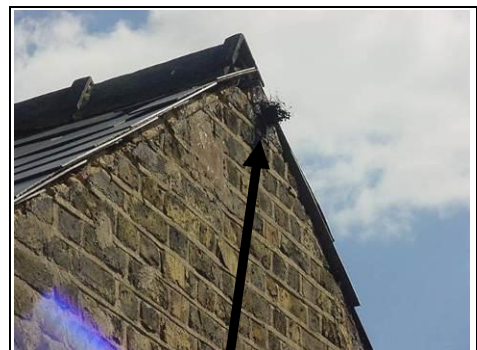
Vegetation growing from the top of the gable

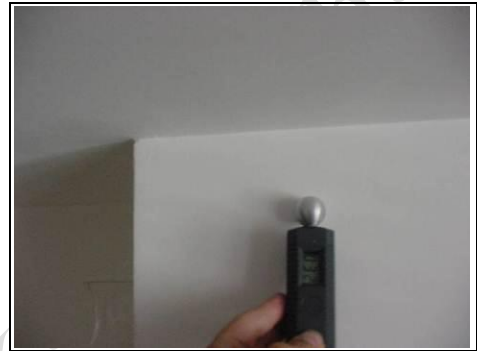
Gann meter reading of 32

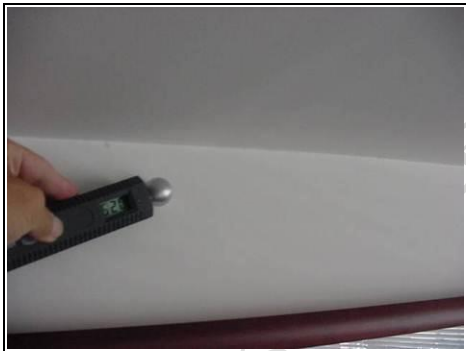
Reading of 29

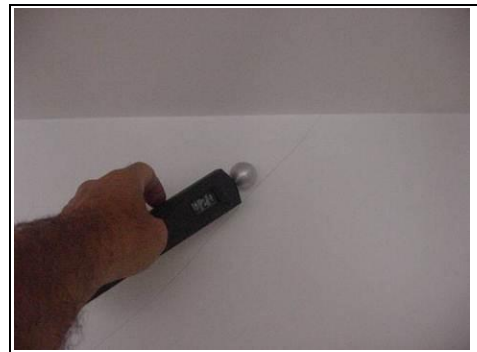
Hairline crack with reading of 28

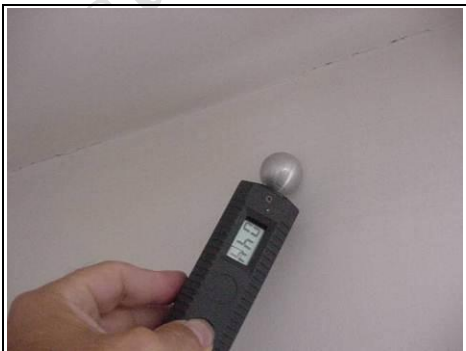
Reading of 44

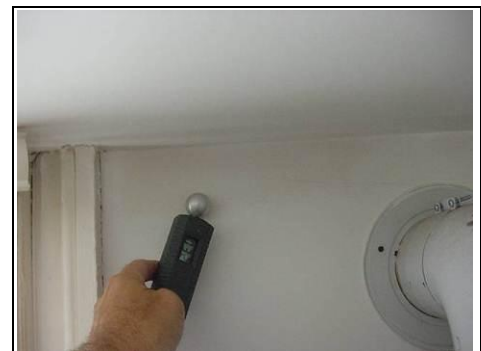
Reading of 32

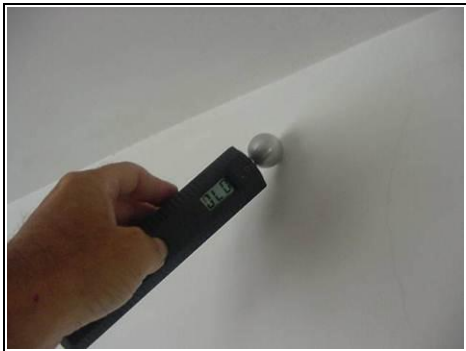
Reading of 70

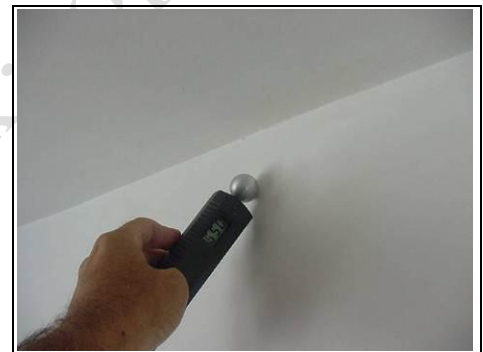
Reading of 59

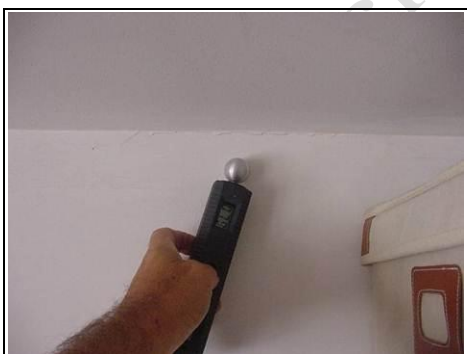
Reading of 79

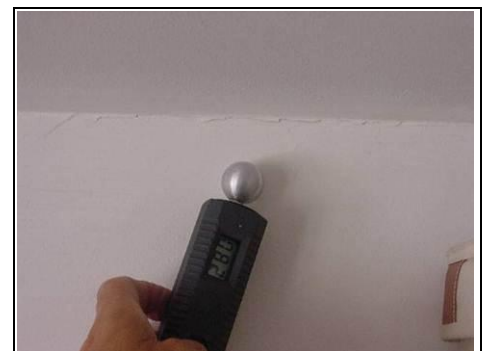
Reading of 82

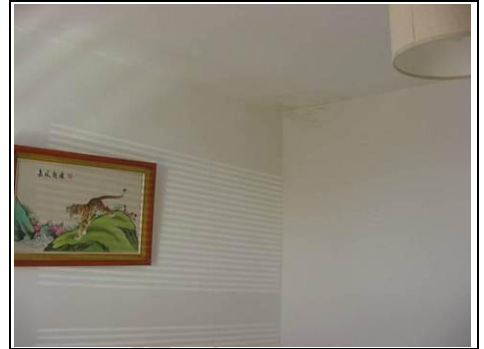
Dampness in the corner of the rear bedroom

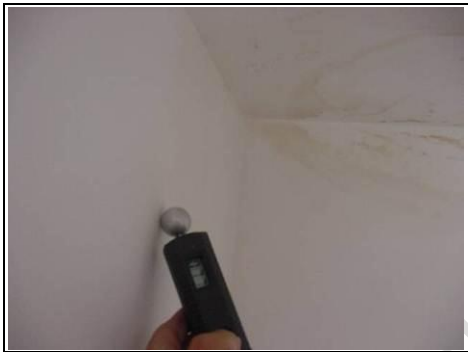
Damp meter reading of 77

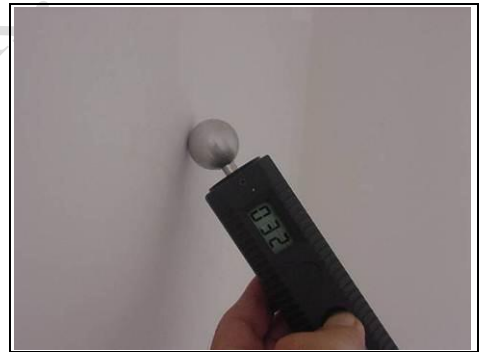
More typical reading of 32

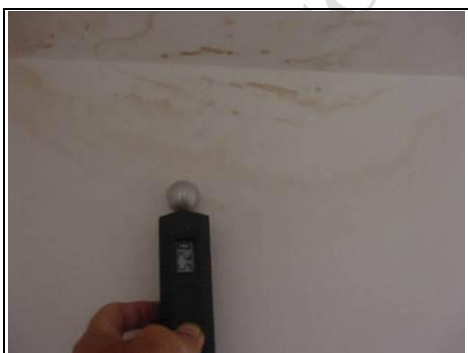
The staining looks to be dependent upon the weather as the reading is currently 25 in some areas meaning that it is drying out

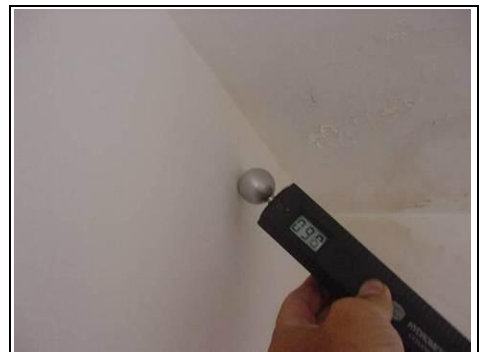
Meter reading of 98

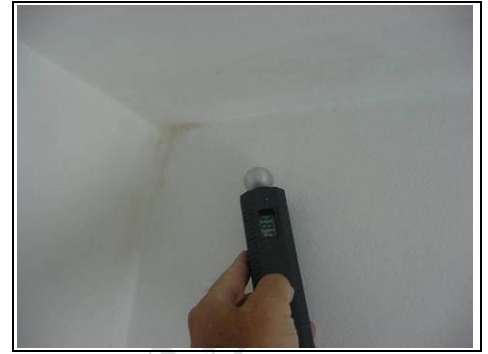
Reading of 85 – left hand wall

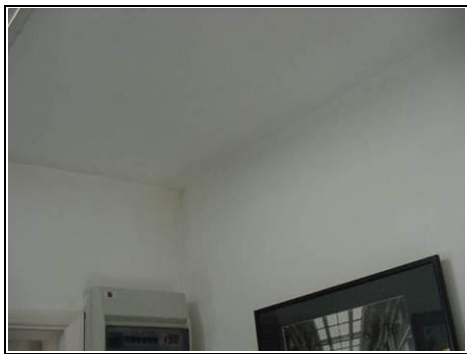
Dampness in the landing

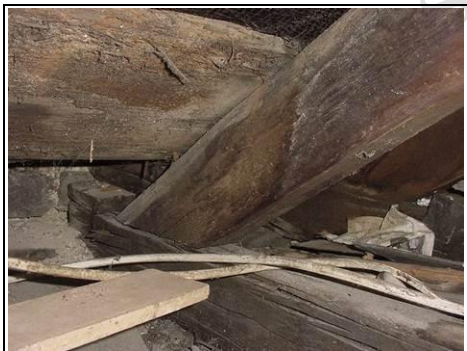
Staining on the timber that is typical from what you see from a leaking valley gutter

4. From our visual inspection within the roof we noted staining to the rafter feet within the property indicating that dampness is coming in through the valley gutters. Our view was limited by being carried out by torchlight.

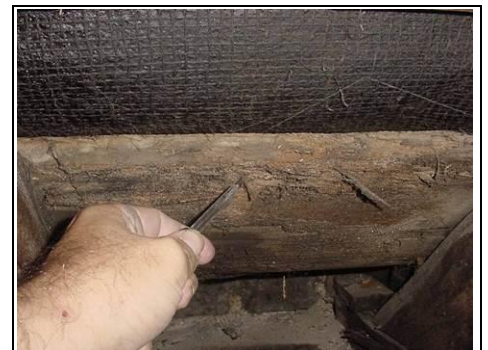
Dampness promotes woodworm. There looks to be old woodworm
