SPECIFIC DEFECTS REPORT

**Relating to dampness
in the Garden Room**

**xxxxxxxxxxxxxxxxxx,
xxxxxxxx, Norwich,
Norfolk, NR15 xxxxxx**

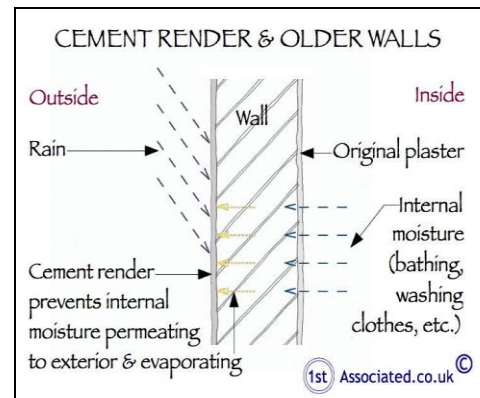
Externally there appears to be a cement render which limits the breathability of the construction (or it may have minimal lime in it). This type of construction means that it does not breathe and cannot dissipate the dampness similar to how a Gore-tex (breathable fabric) overcoat would but instead is acting as a raincoat which is not typically what is found in older buildings such as this although we appreciate this is a 'new' construction.

Cement render

ACTION REQUIRED: Check with the developer to see how the exterior of this building should work and possibly take samples to see if there is a lime content.

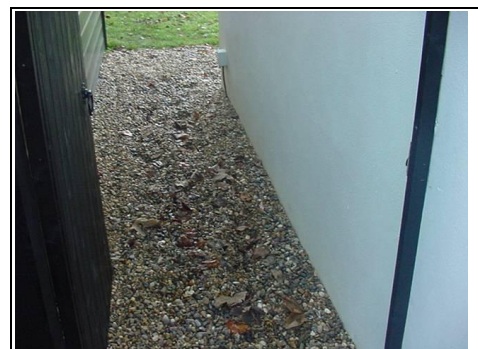
The render runs directly down to the ground and as such could be bridging the damp proof course causing capillary action drawing dampness into the building. We were unable to physically see a damp proof course.

Render runs directly into ground with no bell mouth

ACTION REQUIRED: Again the developer to confirm if there is a damp proof course. Ideally we would prefer a bell mouth detail to the base of the render as this will stop the capillary attraction being drawn from the ground.

ANTICIPATED COST: In the region of £2,000 to £4,000 (two thousand to four thousand pounds) to have a properly detailed bell mouth render added and appropriately re-decorated; please obtain quotations.

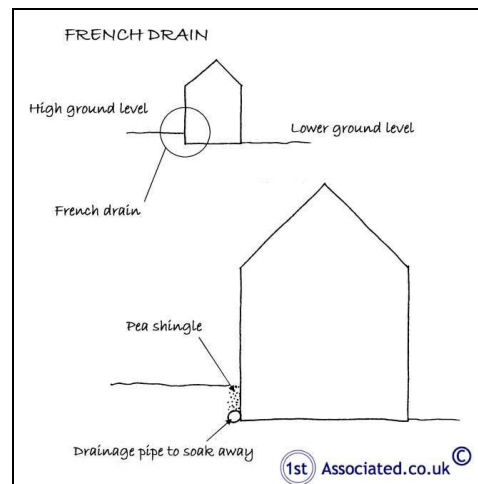
The French Drain that is around the property has been dug up in two sample areas, one to the front and one to the rear of the property, and from what we can see this is not a functioning French Drain. We would have expected it

1. To be deeper
2. To have a run off of some sort for the water that has been collected.

French Drain

ACTION REQUIRED: Add a fully functioning French Drain

ANTICIPATED COST: £3,000 to £5,000 (Three to Five thousand pounds); please obtain quotations.

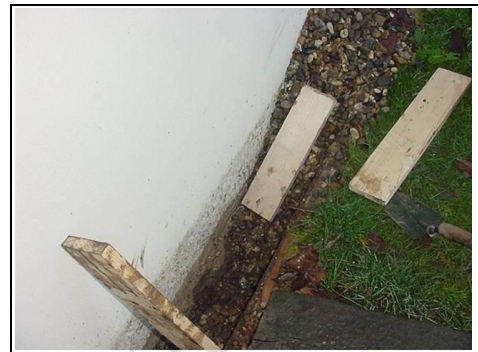
French drain (front) dug –up
to approximately 150mm deep

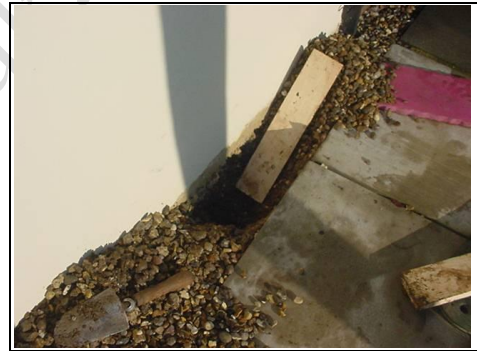
French drain (rear) dug-up
approximately 100mm deep

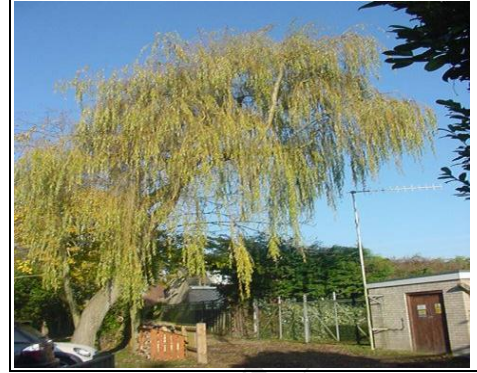
We would also make the general comment that today we are often building on land that our ancestors would not have built on due to the natural factors such as the water level in this area. As such we are causing ourselves problems that we have not come across in the past. As we explained some of the issues we are looking at do not have a clear quick way to resolve them. As there is likely to be a high water level table the building should have been built with this in mind.

Weeping willow indicates a lot of water in the ground

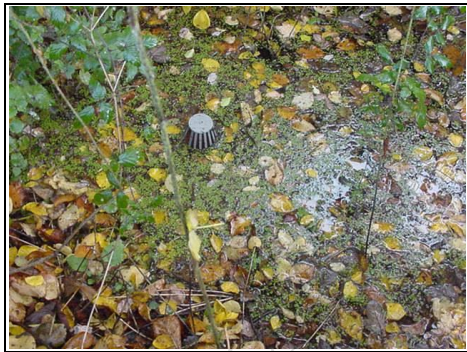
Stream nearby (far left) with is possibly where the water drains to from the land

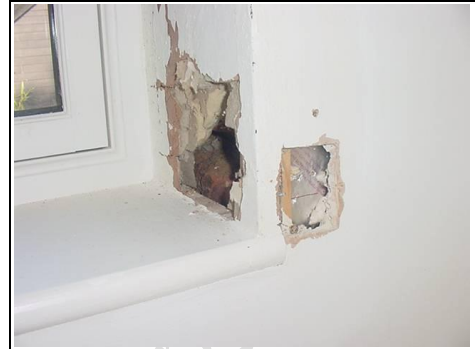
Traditionally there would have been a brick closer around the windows to the reveals. In this instance we simply cannot see anything other than the plasterboard. This has deteriorated

No cavity closer

ACTION REQUIRED: A suitable cavity closer needs to be added and the plasterwork made good.

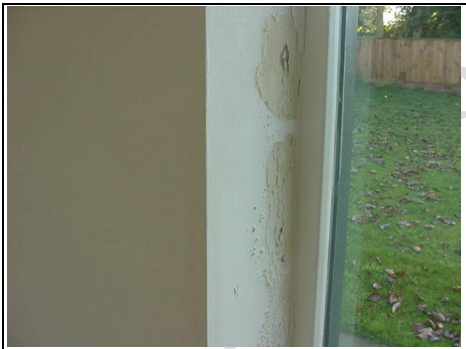
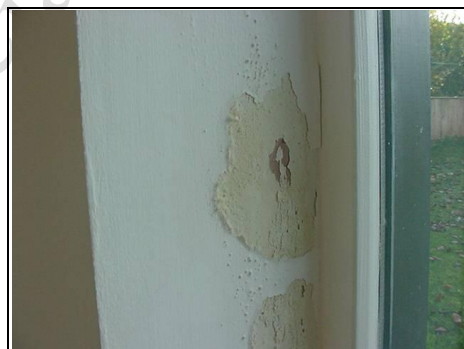
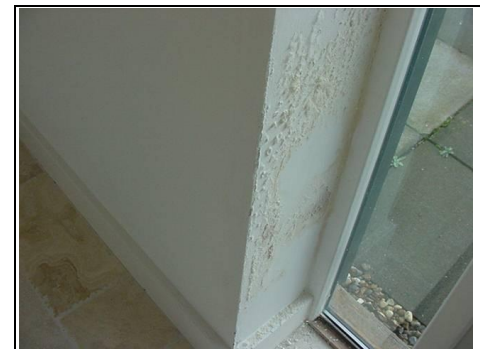
The dampness to the door and window reveals was considerable. This indicates that door closers are not present. These areas indicate a general design fault.

Close up of deterioration

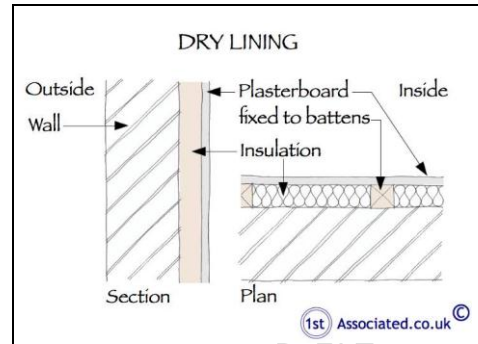
Electronic resistance/ damp meter readings were taken throughout the interior of the property and we identified spot areas of dampness indicating general defects in the construction of the dry-lined walls. There seems to be a lack of membrane in the walls to prevent the dampness coming through.

ACTION REQUIRED: The walls need to be opened up to be checked for their construction and appropriate amendments made.

ANTICIPATED COST: Not possible to cost without opening up the walls.

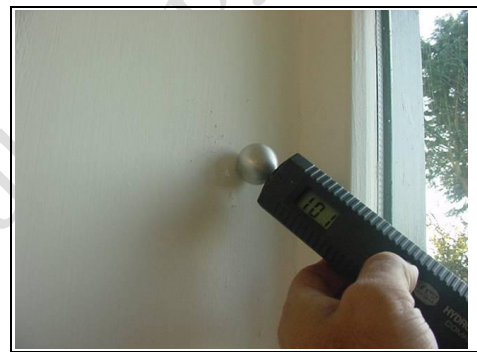
Damp meter reading of 101

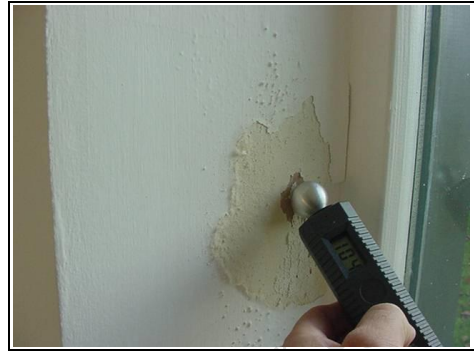
The resistance meter readings were over and above what we would expect for a dry-lined wall which would typically be 15-30. In this case we were receiving readings of up to about a hundred.

Damp meter reading of 104
on the reveal

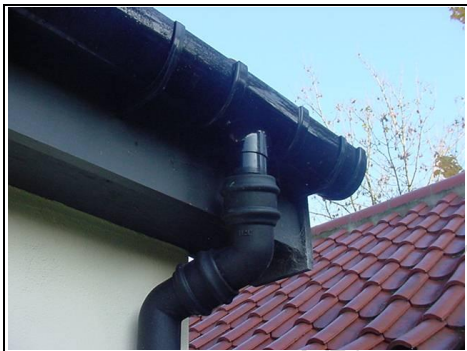
Guttering to downpipe needs to be checked it is watertight.

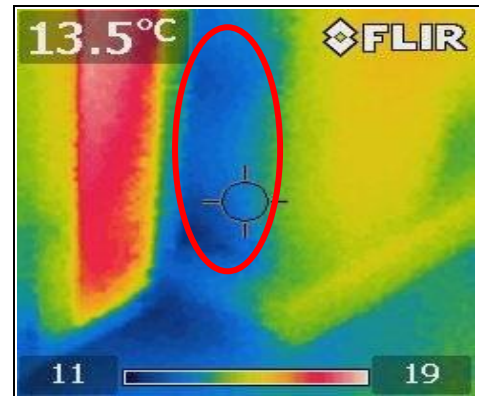
Thermal image shows coldness on reveal of the window

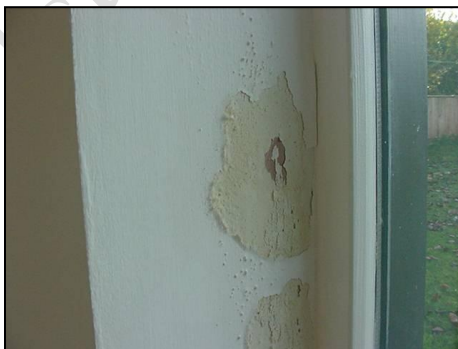
Flaking reveals

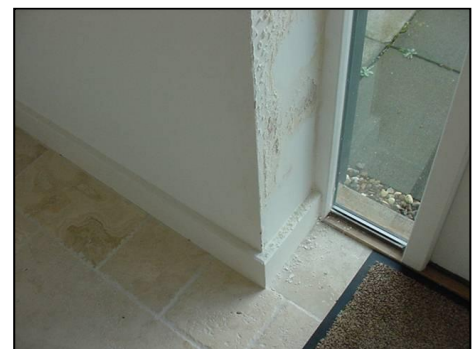
Reveals to the rear wall are flaking

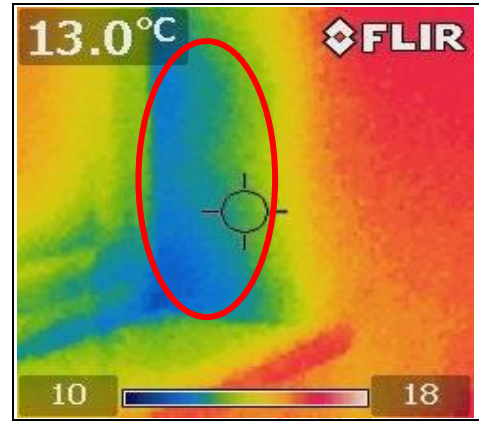
Thermal image shows coldness on reveal of window

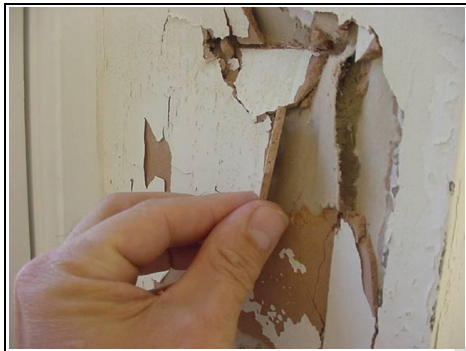
Skim coat of plaster that's been put on top of plasterboard. This is saturated.

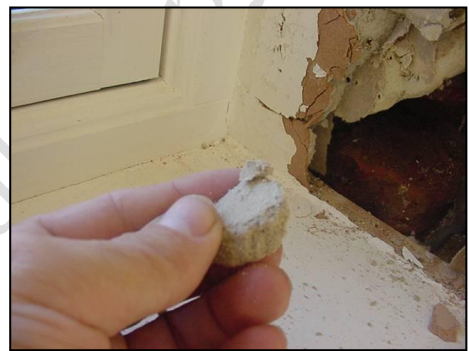
Saturated plasterboard to the reveal of the window

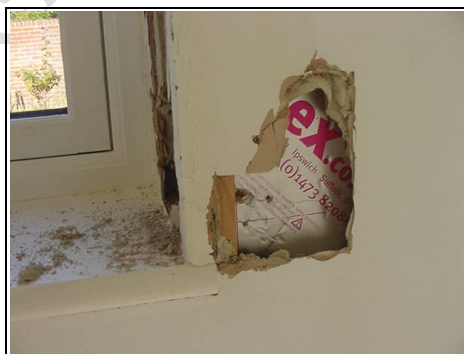
Celotex insulation board visible to the wall side of the window
