# EXTERNAL DEFECTS REPORT

**Relating to  
xxxxxxxxxx  
Camden  
London. NW1 xxx.**

**Mr D**

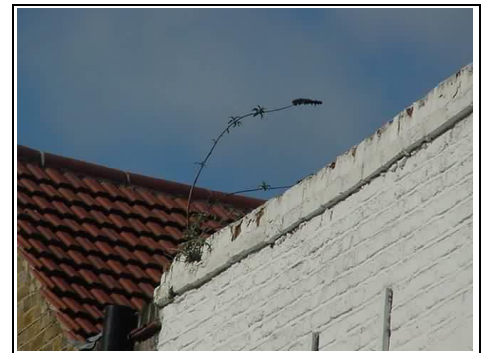
Roof

We could see there are roof problems to the property although we have not accessed the roof.

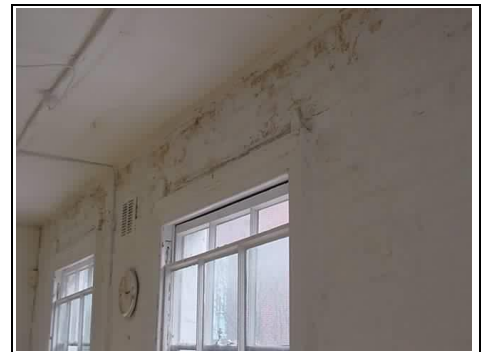
To the front of the property there is a parapet wall which is hiding problems and we believe there to be a box gutter behind this. Box gutters commonly get blocked and as such you are seeing the dampness coming through internally to the top floor visible on the front wall.

View of area internally

**ACTION REQUIRED:** Clear box gutters, check condition, re-lead if necessary, allow to dry out and then redecorate.

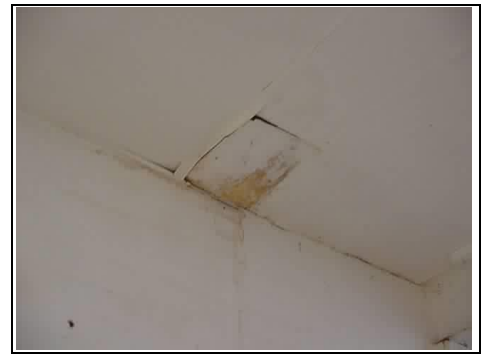
We could see in some areas that there are other roof leaks for example mid way down on the left hand side (all directions given as you face the property) there is a roof leak visible on the first floor level.

Roof leaks

**ACTION REQUIRED:** We would recommend access is formed up through one of the roof windows and the roof is viewed. The roof may not be safe to climb on.

We think it is likely that the roof needs cleaning and there maybe some flashing problems that need resolving.

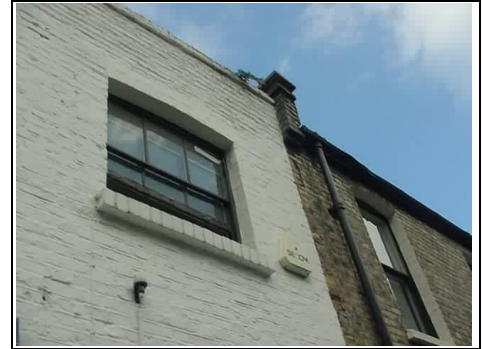
Front of property

Some of the dampness has been caused by the wrong paints being used externally which in turn affects the property with it not being able to breathe. This in turn is resulting in lateral dampness and rising damp particularly visible at the front ground floor offices.

**ACTION REQUIRED:** Once you have made sure the property is watertight and the walls have dried out we recommend experiment on an area with a modern micro-porous paint or equivalent older style breathable paint

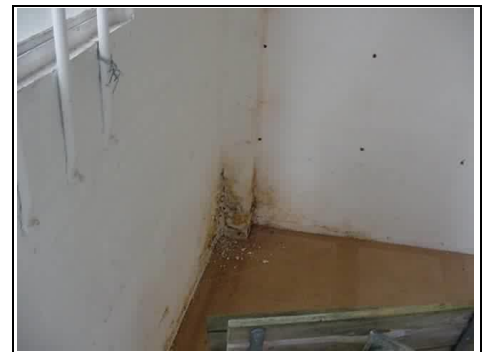
There is high ground level to the rear of the property which is causing dampness internally. We also note that this looks to be a single brick construction which are always damper than traditionally one brick thick built structures.

Signs of dampness

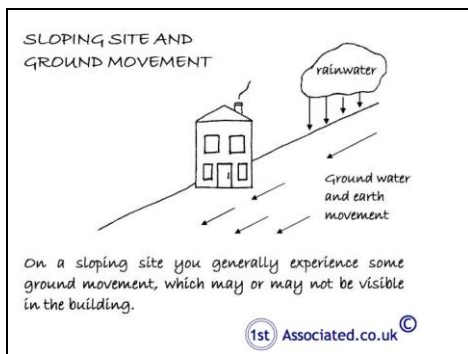
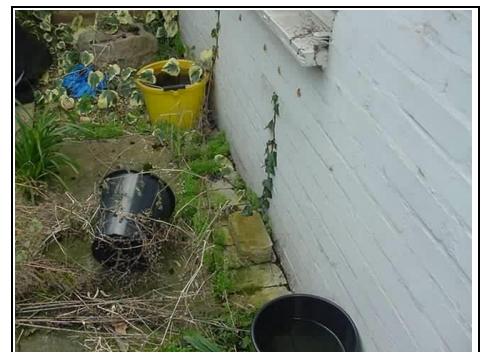
High ground level

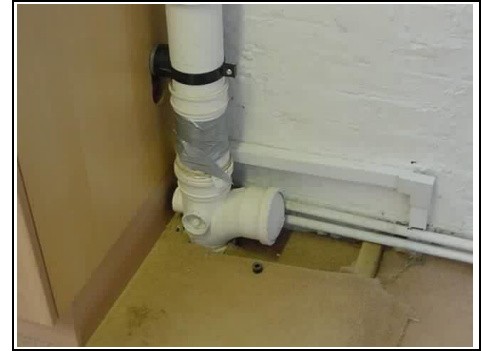
Whilst it could be argued that this is a tenant's responsibility we can see that the soil and vent pipe has had various DIY repairs over the years.

DIY repairs to soil and vent pipe

**ACTION REQUIRED:** Repair soil and vent pipe.

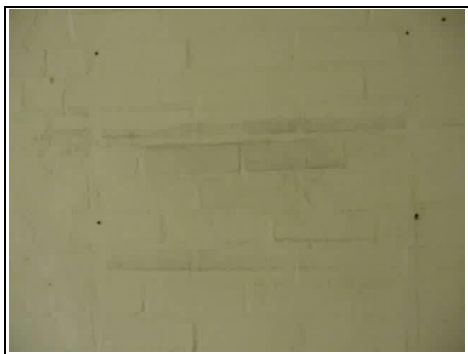
Pattern staining in open plan office

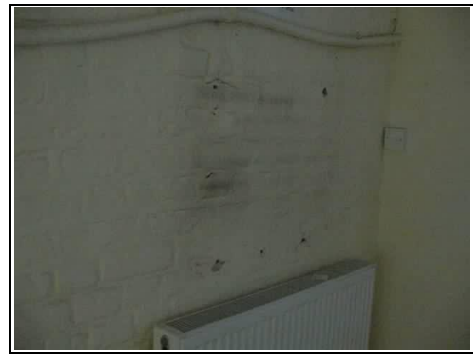
More pattern staining in open plan office

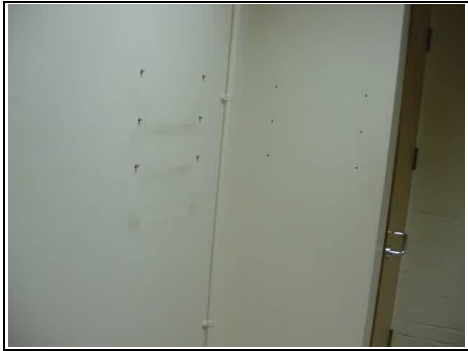
General fixings that have been left

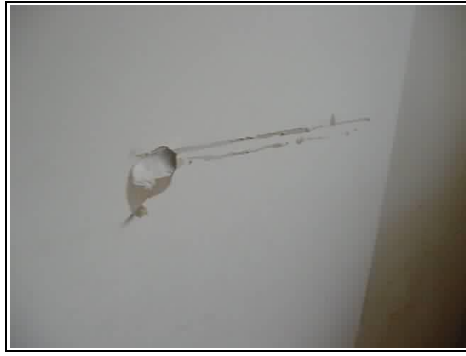
Damage to wall, small internal office

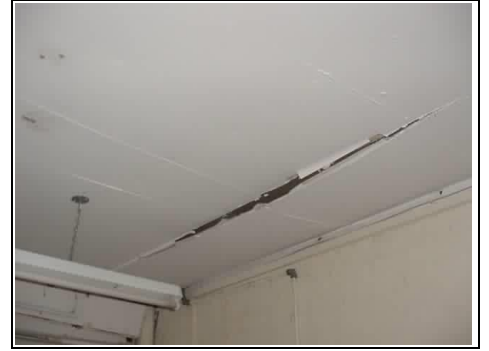
Ceiling in garage showing soil and vent pipe problems

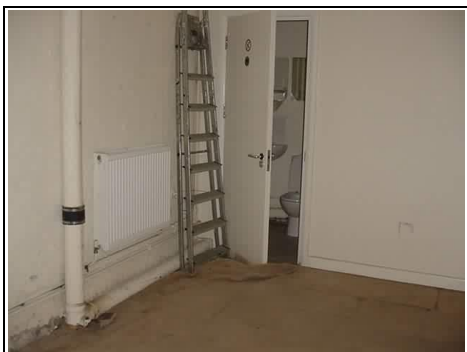
Deteriorating carpet in garage

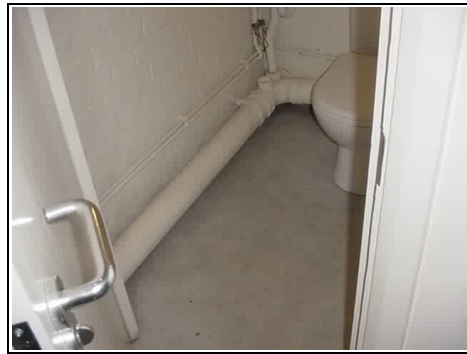
Soil and vent pipe needs cleaning  
and painting

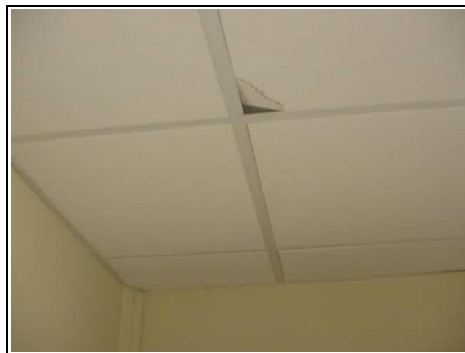
Broken ceiling tile in computer room

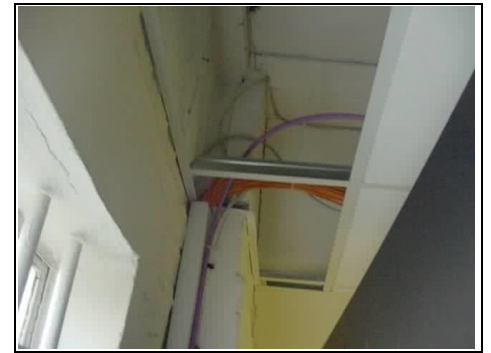
Missing tiles in ceiling in computer room

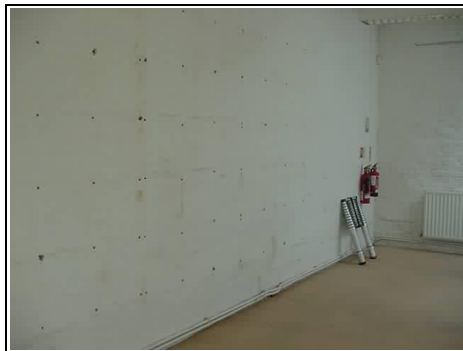
Open plan office fixing points not removed

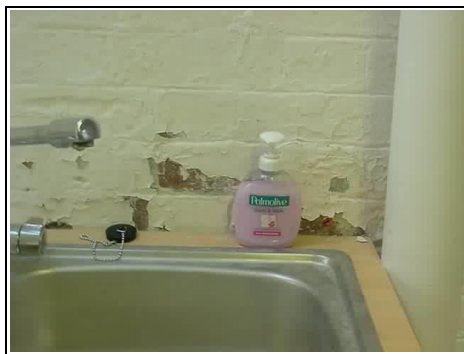
Flaking paint to wall in kitchenette

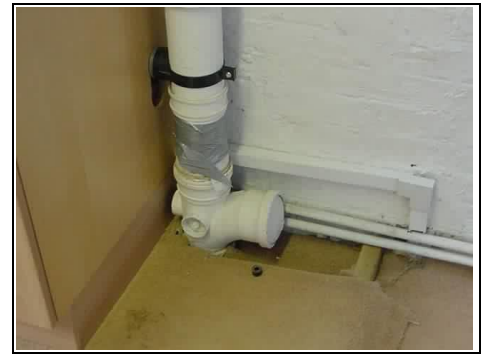
DIY repair to soil and vent pipe

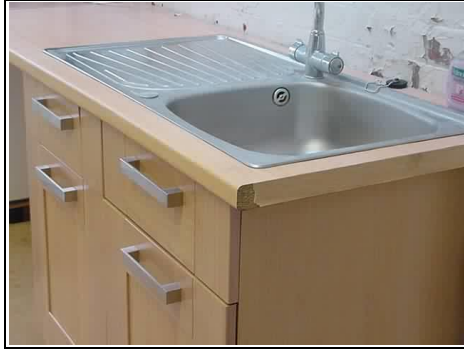
Damage to kitchenette wall

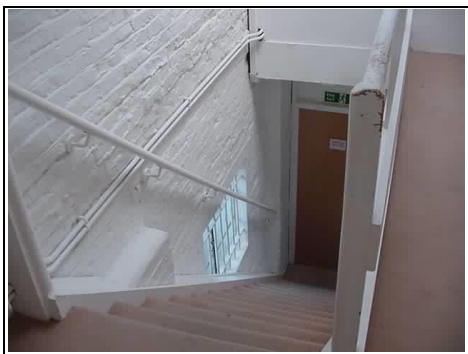
Handrail worn

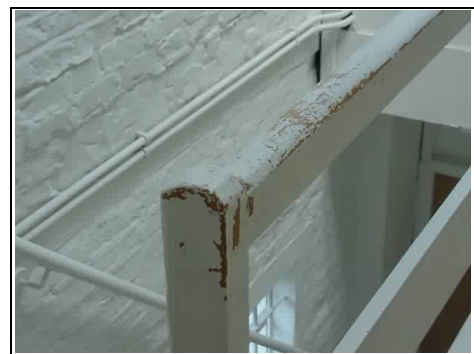
Close up of worn hand rail
