SPECIFIC DEFECTS REPORT

**Relating to dampness
from various roofs**

STAFFORDSHIRE

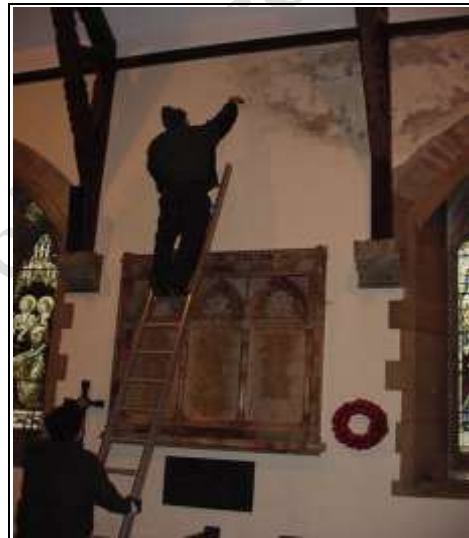
Deterioration to the South Aisle

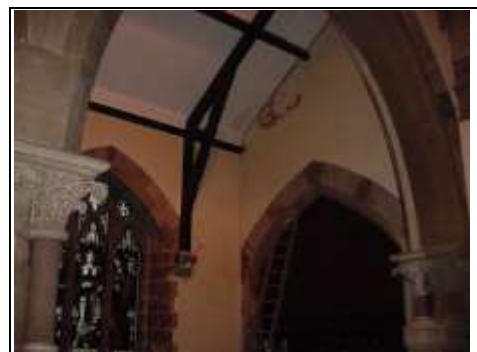
Deterioration to the North Aisle

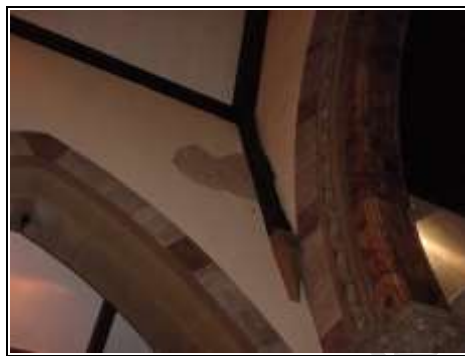
Deterioration to the North Aisle

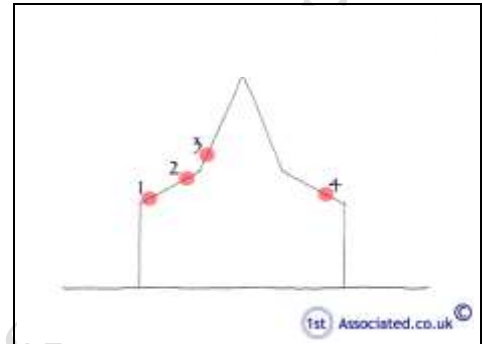
There is also opening up to the main Nave roof at low level. In each case there were areas of tiles removed in areas 1, 2, 3, and 4 as shown in the adjoining sketch.

There was a sample taken at point 4 as noted in the above sketch.

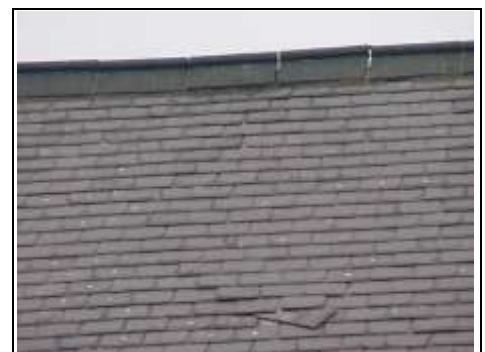
The slate roof showed approximately ten to twenty percent of slipped slates. We are advised from discussions with contractors that these are copper nailed and if fixed properly should give a long life. We also noted that the ridge was starting to deteriorate.

Slipped slates and deteriorating ridge tiles.

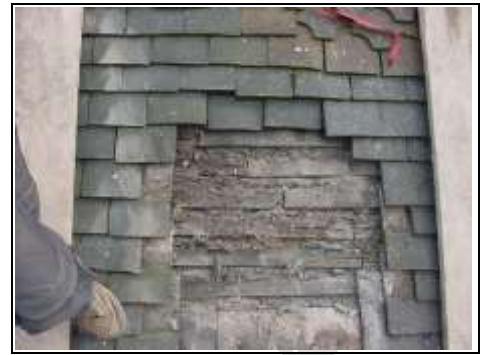
The areas inspected on the North Aisle roof and the lower part of the Nave roof generally showed the battens in the worst condition. The roof tiles were clay and concrete in this instance. We also noted areas where the gutters were not watertight.

Our main concern in this area is the condition of the battens.

Exposed area on the Nave roof.

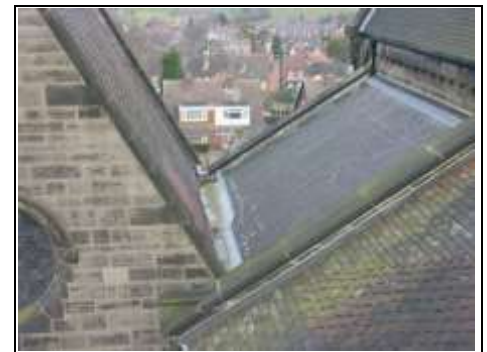
There is also a valley gutter to the far north east roof area above the Vicar and Choir Vestries. Whilst we did not access this area we could view it and we believe it to be problematic as is the case with many valley gutters. Please see our common problem sketch below.

We can also see the roof has been repaired with lead tingles indicating deterioration.

Valley gutter to north east roof

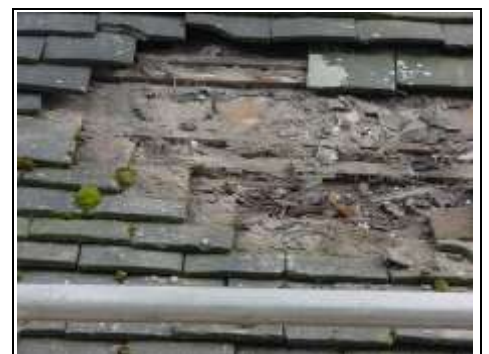
The shallow pitched roofs of the North Aisle are likely to require the most work as the battens are starting to deteriorate. However we would also say that as this is a north elevation there may also be the same problem to the main roof.

Deteriorating battens

Batten deterioration would mean the removal of all the roof tiles, the removal of the batons themselves and then the felt. The felt was literally disintegrating as we touched it.

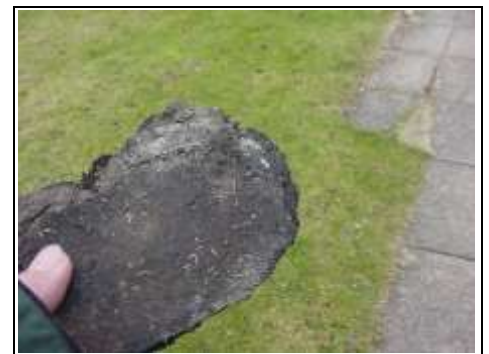
Disintegrating felt

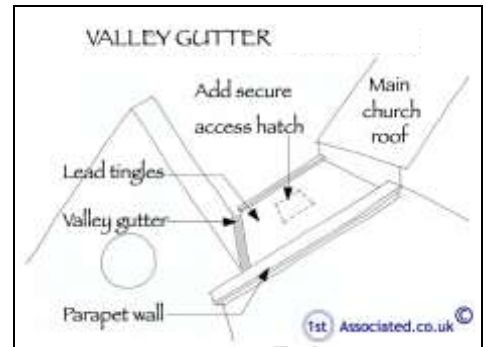
There is a problematic area to the north east aisle roof that forms a valley gutter. This is above the Vicar and Choir Vestry areas and needs specific attention and further investigation. However from what we saw we feel it needs a change in the design.

The current gutters look to overflow (although it was not raining at the time of our survey so we cannot be certain). We feel a larger hopper head should also be provided.

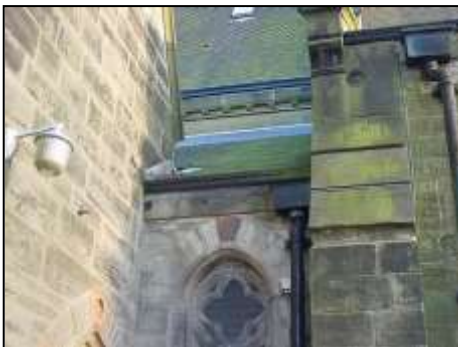
Overflowing valley gutter to north door entrance

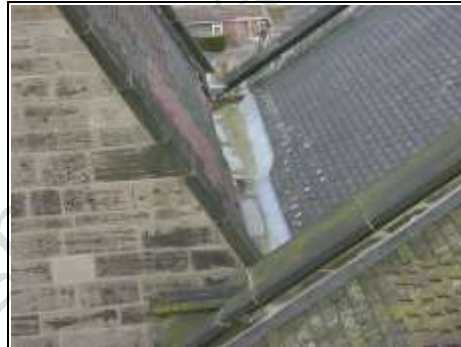
Valley gutter with lead tingles to the central area

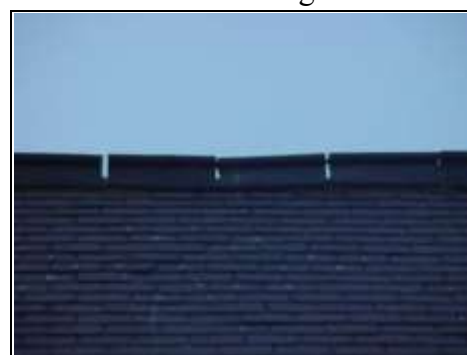
Nevertheless there is, as can clearly be seen, problems with slipped slates. We would have expected to see some tingles if the nail fixings had rusted. Please see our previous comments on tingles.

Overview of slipped slate to the south elevation

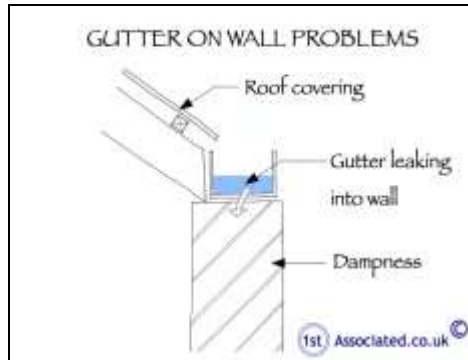
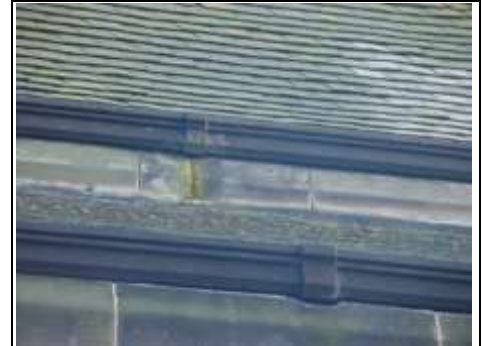
We feel a weak area with regard to both sides is the design detailing where the gutter sits on the wall and a close up visual inspection needs to be made.

Leaking gutter sitting on a wall.

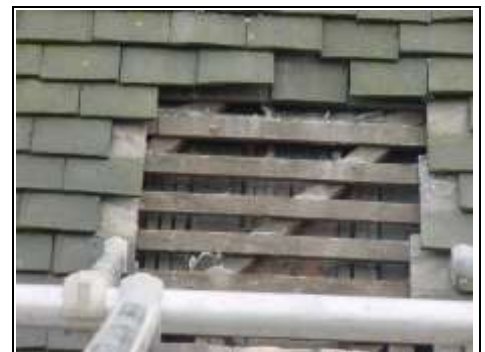
Battens and underlayer exposed on north elevation high level roof

We would expect extensive work to the north elevation partly re-roofing and re-battening and with the adding of a modern protective underlayer. The work will be carried out during the summer months.

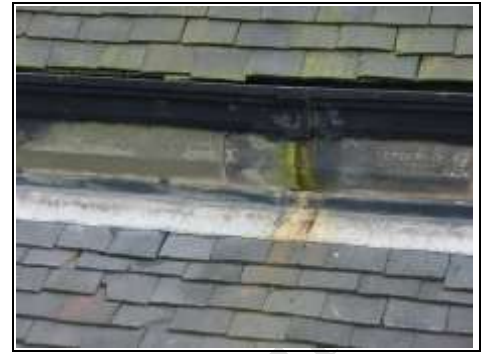
Leaking gutter

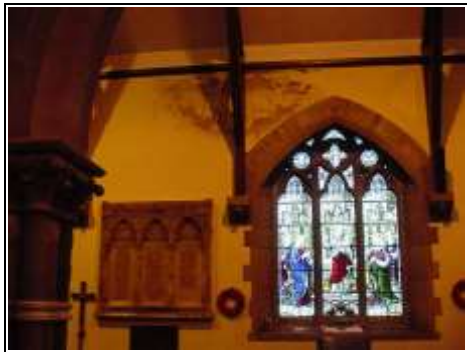
South aisle with efflorescence and dampness at high level

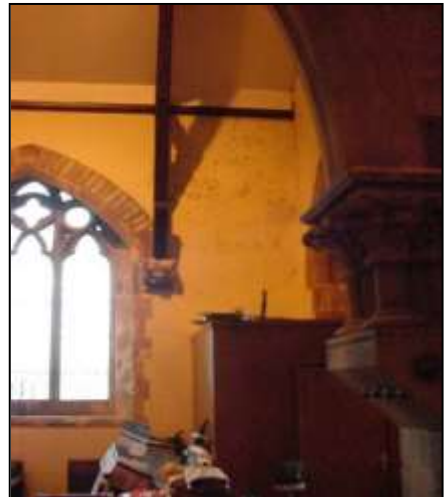
Front of the south aisle with efflorescence at roof level

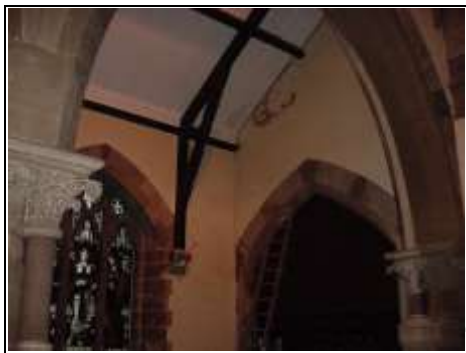
High level dampness to the Vestry side of the church

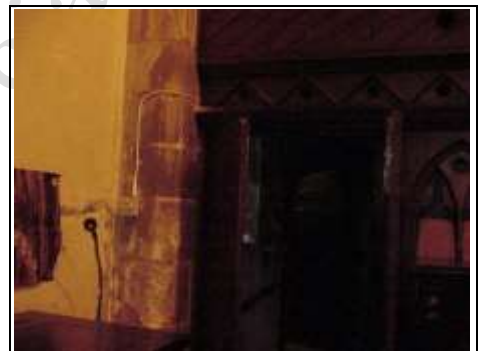
Low level dampness to the north aisle

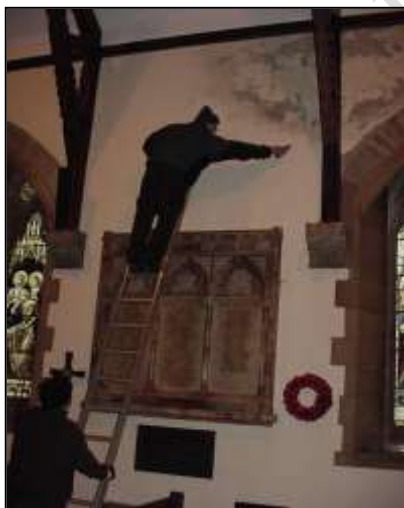
Room	Readings Obtained	Typical Readings
North aisle –north wall	High level 40 & 54 Medium level 58 & 57 Low level 90 & 87	40s-50s
This indicates that dampness is coming from either a ground source or a leaking gutter.		
North aisle – east wall	High level 38 & 46 Medium level 86 & 57 Door level 45 & 53	40s-50s
This indicates that dampness is coming in via the roof. We also took spot readings on the dampness at low level and obtained readings of 90 & 93.		
South aisle - window	High level(approx 4 metres high) 36-40 Medium level (approx 3 metres high) 37-50	40s-50s
South aisle –west end	45 & 48	40s-50s

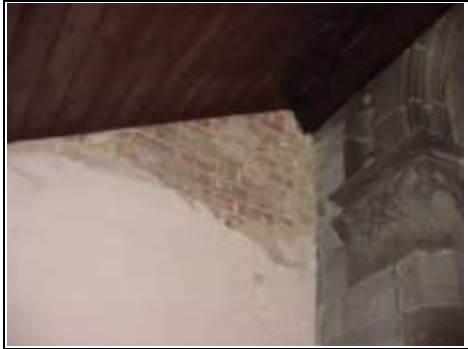
10.1 In this instance we have not been able to access the roofs structural area. We have only been able to access the Vicar's Vestry which gave us a limited view of the valley gutter. The view that we could see, due to the plaster coming off the wall, indicated dampness has been present in this area for some time.

Dampness has caused the plaster come away

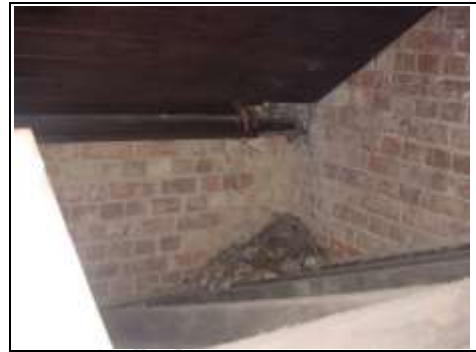
There has been some disturbance of the roof
