SPECIFIC DEFECTS REPORT,

**Relating to Moving/Deflecting Wall,
First Floor**

**A School in
Essex**

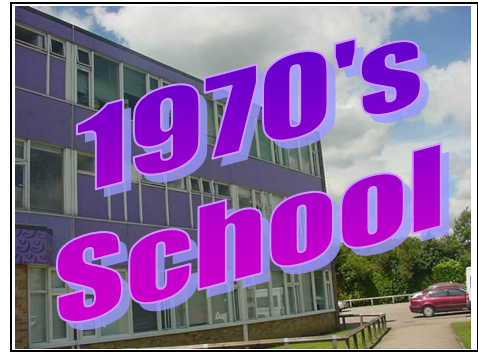
General view of School

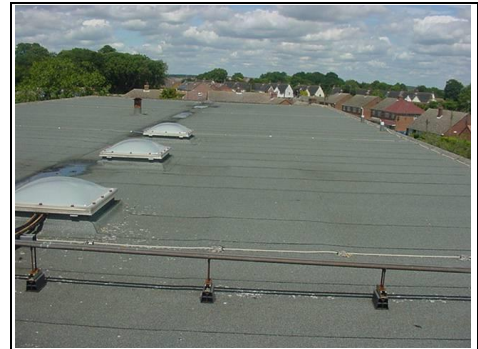
This is a mineral felt covered with a shallow pitch to a central gully known as a butterfly roof, with roof lights. There is no safety bolts as far as we could see and we would recommend these are added for future maintenance/inspection of the roof, for example for things like this problem.

Shallow butterfly roof

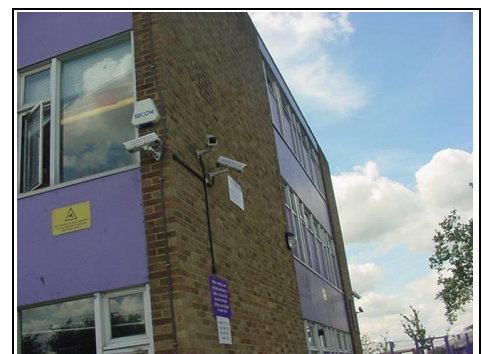
Gable brick wall construction with timber, or other proprietary panel located beneath the windows and painted purple.

Cross wall construction

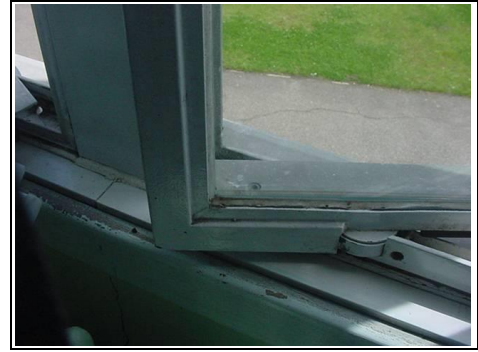
Single glazed windows into a metal frame, typically known by its generic name of Crittle windows.

Metal single glazed window

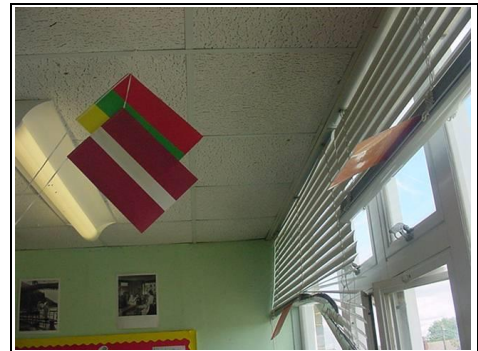
Mineral suspended tiles, with a concrete block system, visible when the suspended tile system was removed for inspection.

Fibre suspended ceiling tile with an exposed suspended ceiling system (on wires)

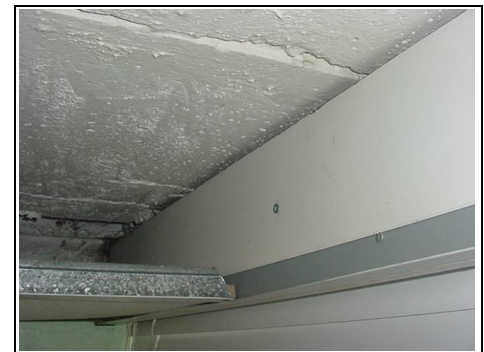
Within ceiling void

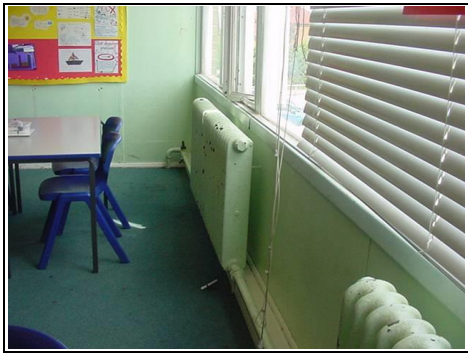
Lower wall and radiator

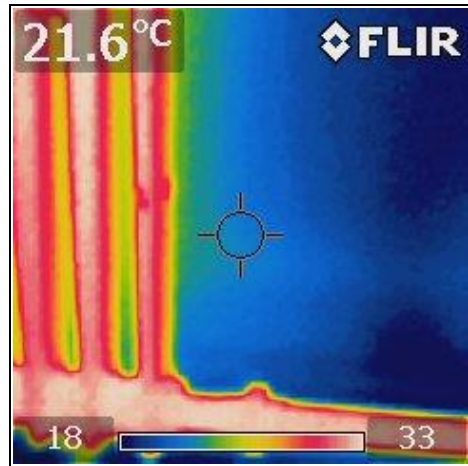
3.1 We returned to thermal image the property. The building was not pre-warmed but it was a relatively cold day and unfortunately we were unable to find any metal brackets that would have an ambient temperature above that of the wall.

Thermal image at lower wall level showing in part the radiator

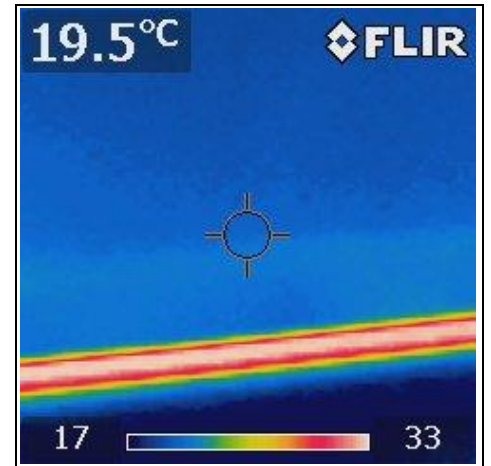
Thermal image at lower wall level
