SPECIFIC DEFECTS REPORT

**Independent Survey
for roofing work
new build
at
XXXX
Wyboston
Nr Bedford
Bedfordshire
MK44 X**

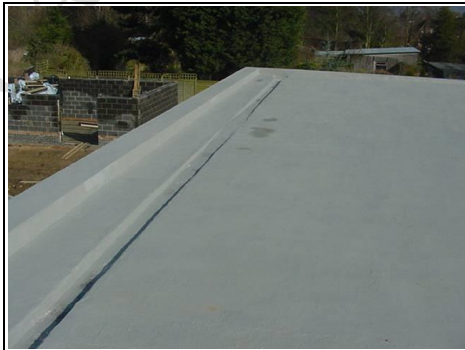
Gulley

The rainwater is taken away via a box guttering system to the rear of the property which discharges approximately one third to right and two thirds to left (all directions given as you face the property from the front).

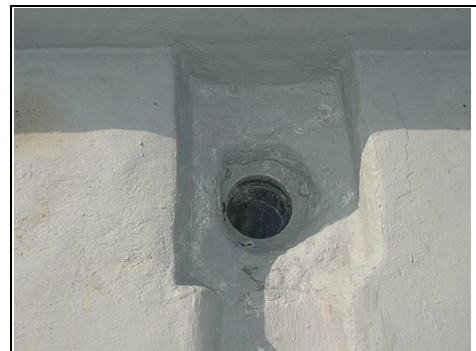
Box gutter to gulley point detail

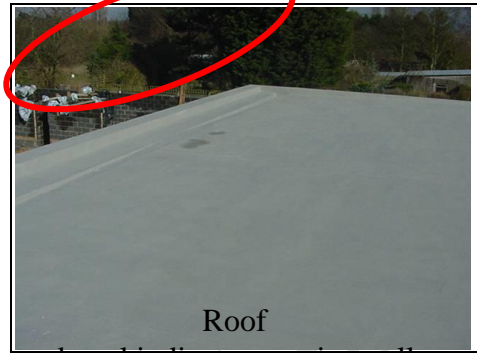
Roof
red oval indicates running gulley

We would conclude from the information we have to hand at present that the outlet is wrongly positioned and there are also possible defects in the roof running gulley detail as well.

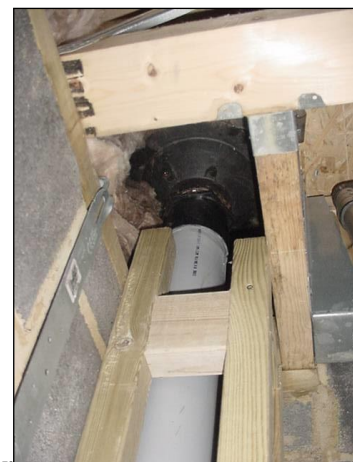
As such it would appear that the positioning of the outlet and construction around the outlet is the main issue assuming that XXX is found by core samples to be a waterproof material which we would expect given that it has been in use for many years; nevertheless we require core sample testing to verify this.

Without opening up the structure it is not possible to understand exactly how the gulley runs have been constructed. It may be that the existing gulley may cause cold bridging (as we believe the cast iron to the outlet is doing) as you can see from our sketches.

Outlet and the downpipe

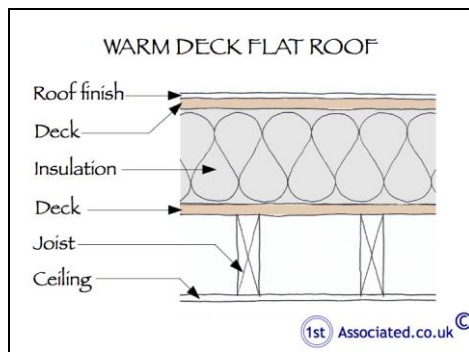
- 5.1 The roof structure we are advised is a warm roof decking sitting onto a composite joist as mentioned the gulley sits below the line of the decking. The Stirling board decking is visible and the underside of the box gutter but not the insulation and top decking. As mentioned, it is not possible to identify without opening up the structure where the outlet sits in relation to all of the above construction.

Warm flat roof

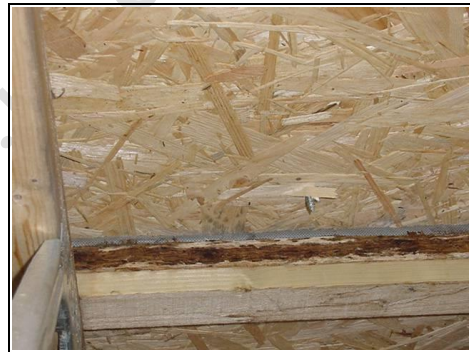
Stirling board decking

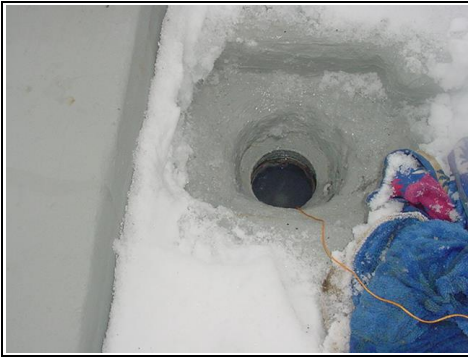
The water test was carried out to the downpipes being plugged approximately 225mm which showed the downpipes to be watertight. The bungs used in water testing would normally be left for half an hour to test the seal unfortunately as there was snow on the roof at the time water was added to this area which filled the downpipe up to roof level and water leaked through.

Water testing

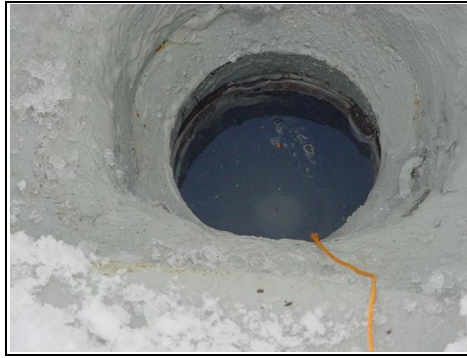
Close up of water testing

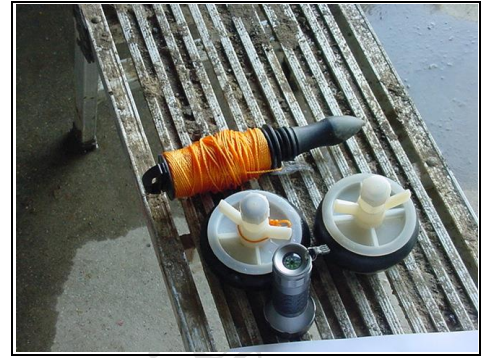
Bungs used for water testing

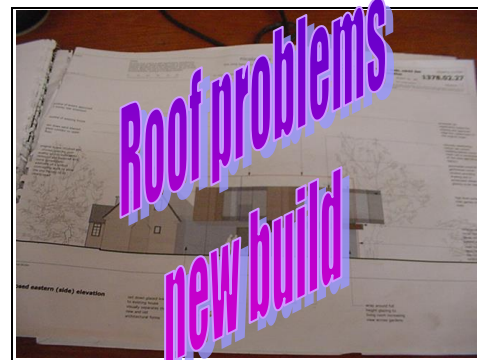
This single storey section is part of a larger proposed development and a feature of this was to have a smooth seamless roof which we would advise without major work this can no longer be achieved.

Proposed development drawing
