# EXTERNAL DEFECTS REPORT

**Relating to  
xxxxxxxxxx  
Camden  
London. NW1 xxx.**

**Mr D**

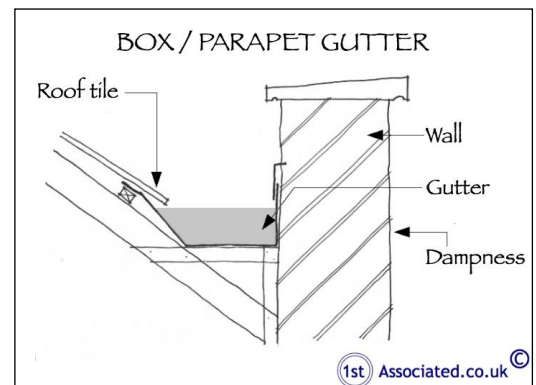
These walls are usually above the roof line and often sit on the boundary of the property. Due to their position they are relatively exposed and suffer from deterioration due to the elements.

**ACTION REQUIRED:** Clear box gutters, check condition, re-lead if necessary, allow to dry out and then redecorate.

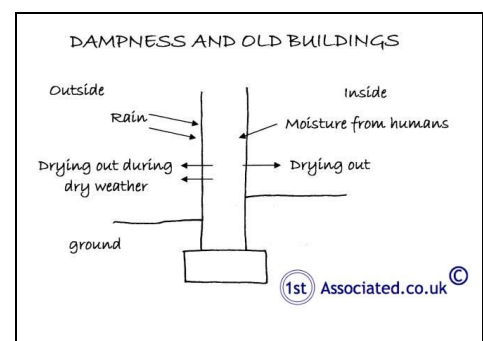
Some of the dampness has been caused by the wrong paints being used externally which in turn affects the property with it not being able to breathe. This in turn is resulting in lateral dampness and rising damp particularly visible at the front ground floor offices.

**ACTION REQUIRED:** Once you have made sure the property is watertight and the walls have dried out we recommend experiment on an area with a modern micro-porous paint or equivalent older style breathable paint
