SPECIFIC DEFECTS REPORT

**Relating to dampness
from various roofs**

STAFFORDSHIRE

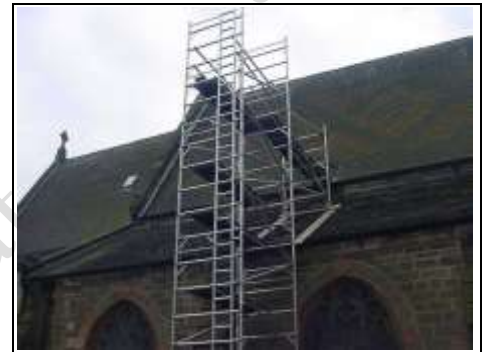
The areas inspected on the North Aisle roof and the lower part of the Nave roof generally showed the battens in the worst condition. The roof tiles were clay and concrete in this instance. We also noted areas where the gutters were not watertight.

Our main concern in this area is the condition of the battens.

North elevation roof accessed via tower scaffolding.

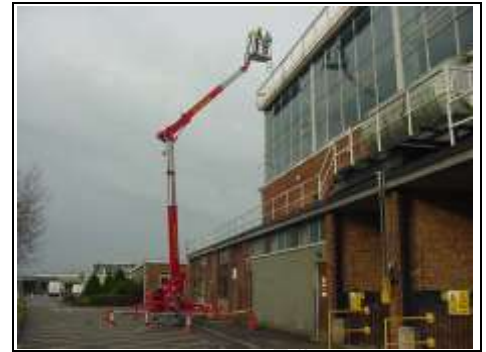
Cherry Picker

The planned maintenance option carries out work to the roof over a four year period (possibly three years) using cherry picker access and adding safety bolts making future repairs easier and safer.

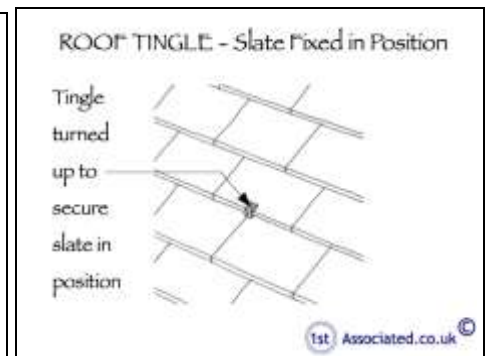
Lead Tingles Defined

These are strips of lead usually about 25mm wide which are used to secure slates where they have slipped.
